# **CRAPO CREEK WATERSHED**

**CONDITION AND IMPROVEMENT NEEDS INVENTORY**

**FINAL REPORT FOR INTERAGENCY AGREEMENT # 14-48-0001-  
93522**

**U.S.D.A FOREST SERVICE  
KLAMATH NATIONAL FOREST  
SALMON RIVER RANGER DISTRICT**

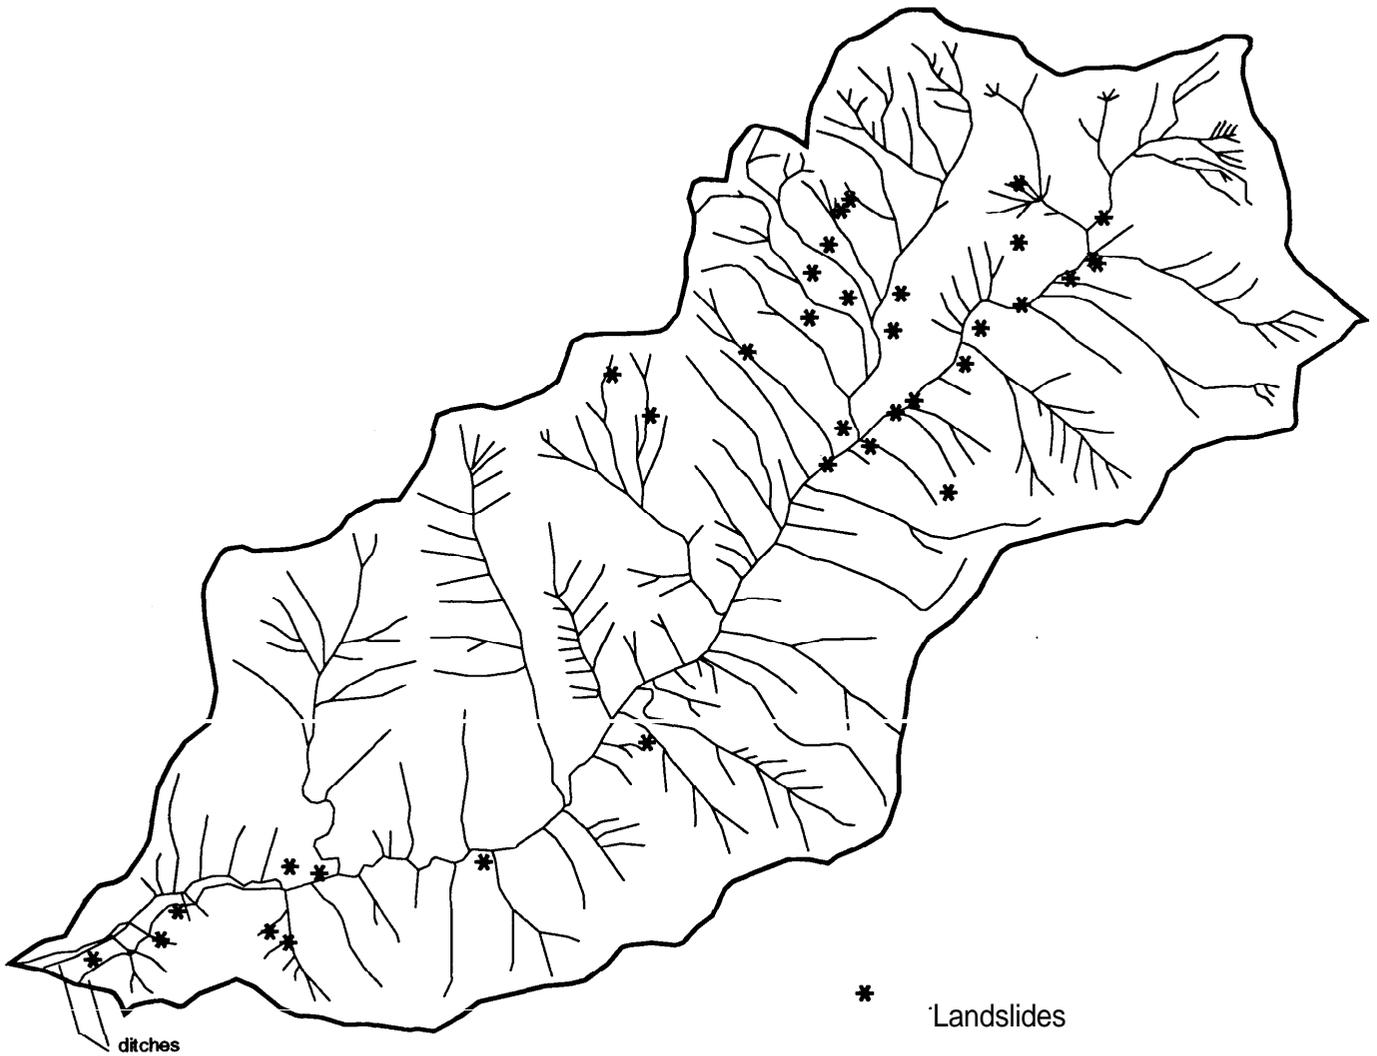
Figure 10

There are many landslides in the upper reaches of the Crapo Watershed. However, they are in loose, shallow soils, and are not accessible or cost effective to repair.

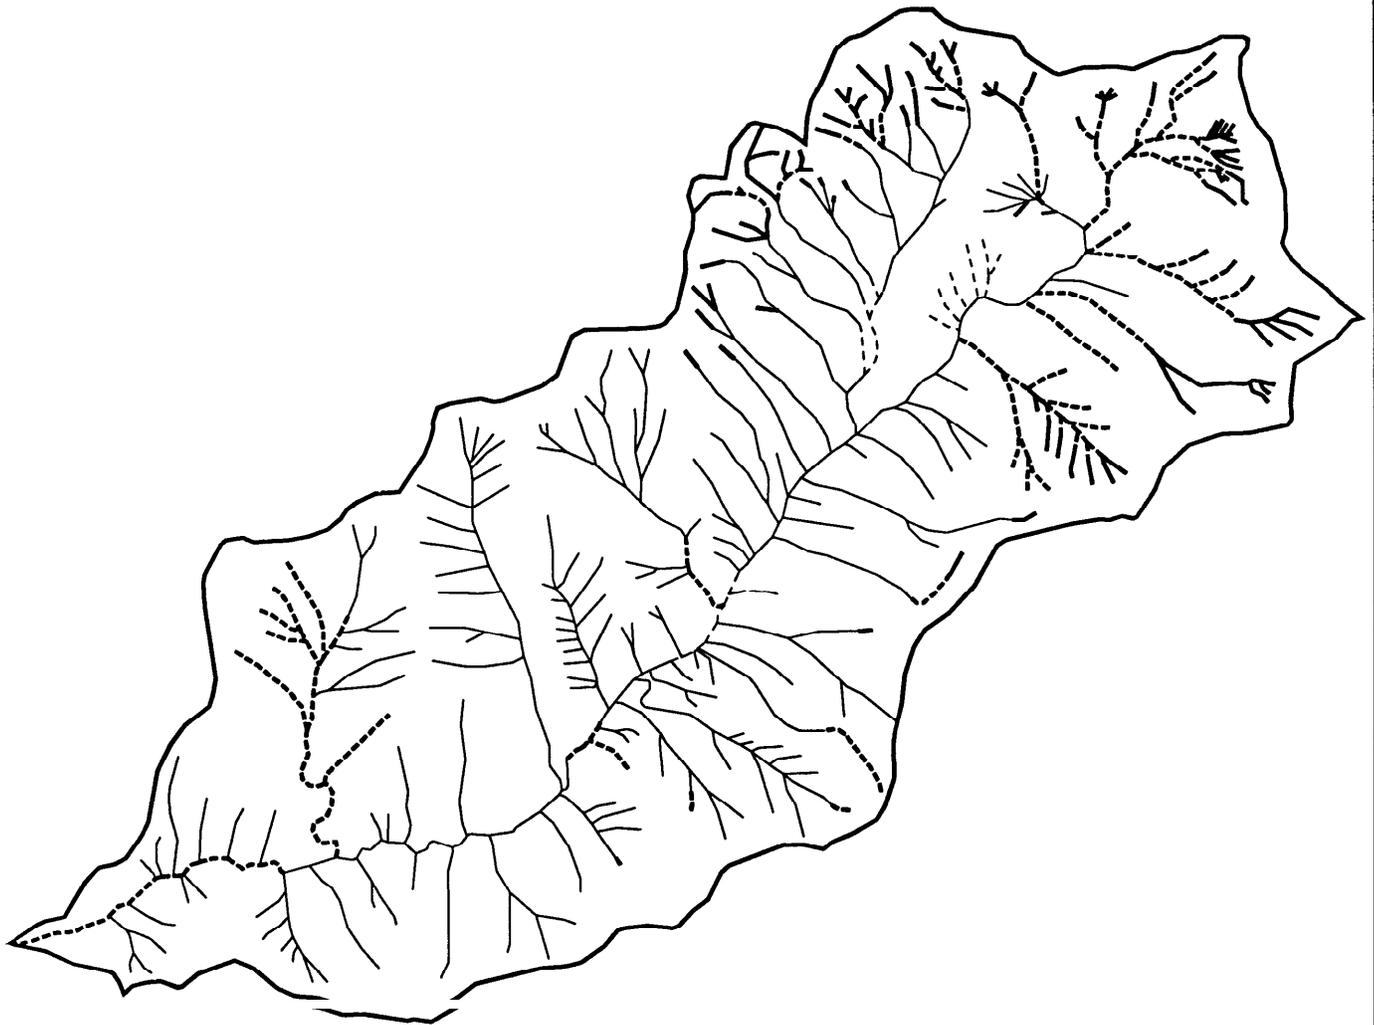
## Pfankuch Stability Ratings

The stability rating for nearly two thirds of the channel system is "fair", followed by nearly a quarter of the length in "good" condition. See Table 1. The third largest class is "excellent", occurring where stable banks and streambeds have influence over other factors. The areas of excellent stability are found predominantly in the headwater meadow areas of subwatersheds D and E. The bulk of the "good" rated streams reaches are found in the tributaries. The only reach of the main stem with good stability is between the confluence and Station 1. Figure 12 shows the distribution of stability ratings. For a more detailed description of channel conditions, see Appendix B, Field Note Summaries by Reach.
