HILLSLOPE MONITORING PROGRAM

MONITORING RESULTS FROM 1996 THROUGH 2001

**HILLSLOPE MONITORING PROGRAM:
MONITORING RESULTS FROM
1996 THROUGH 2001
December 2002**

**by Peter H. Cafferata and John R. Munn
California Department of Forestry and Fire Protection**

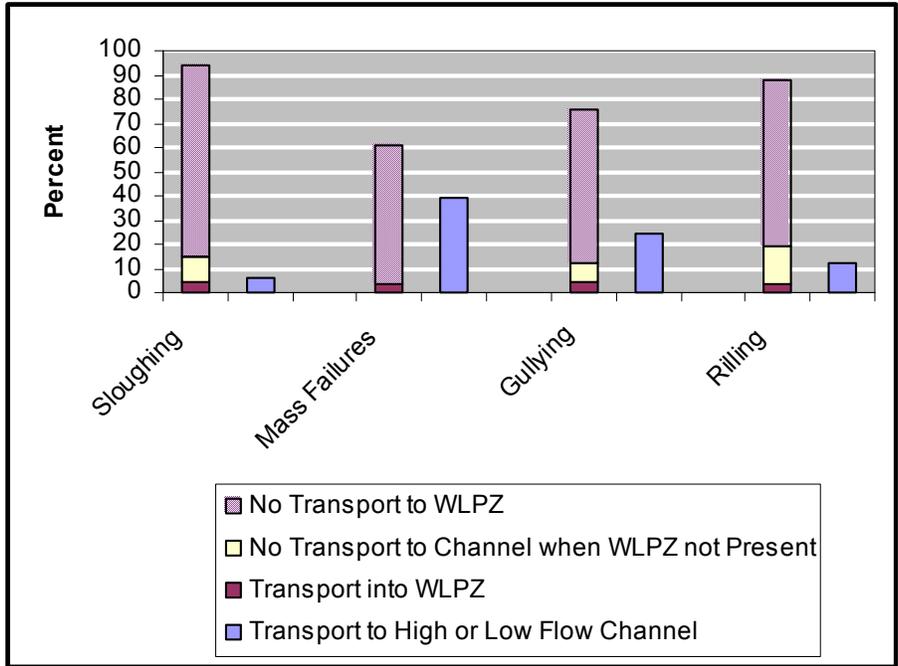
The sediment delivery percentages to the high flow channel are similar to those reported in the interim Hillslope Monitoring Program report, after the evaluation of 150 THPs (CSBOF 1999). In that report, it was stated that the percentage of sloughing, mass failures, gullying, and rilling features delivering sediment to the channel was 6 percent, 47 percent, 18 percent, and 13 percent, respectively. Following the evaluation of 300 projects, the percentages of sediment delivery to the high or low flow channel for sloughing, mass failures, gullying, and rilling features are 6.2 percent, 39.3 percent, 24.5 percent, and 12.6 percent, respectively (Figure 9). No sediment was transported to the channel for 93.8 percent of the sloughing features, 60.7 percent of the mass wasting features, 75.5 percent of the gullies, and 87.4 percent of the rills. Of the rills that delivered sediment to watercourses, 70.2 percent delivered to Class III watercourses. For gullies that delivered sediment, 49.2 percent input sediment to Class III watercourses. Sediment delivery data was not reported for 4.8 percent of the rilling features, 1.1 percent of the gullies, 6.7 percent of the mass failures, and 23.4 percent of the sloughing events.

Figure 9. Percent of erosion features with dry season evidence of delivered sediment to the high or low flow channel of a watercourse from road transect erosion features related to the current THP or NTMP NTO.

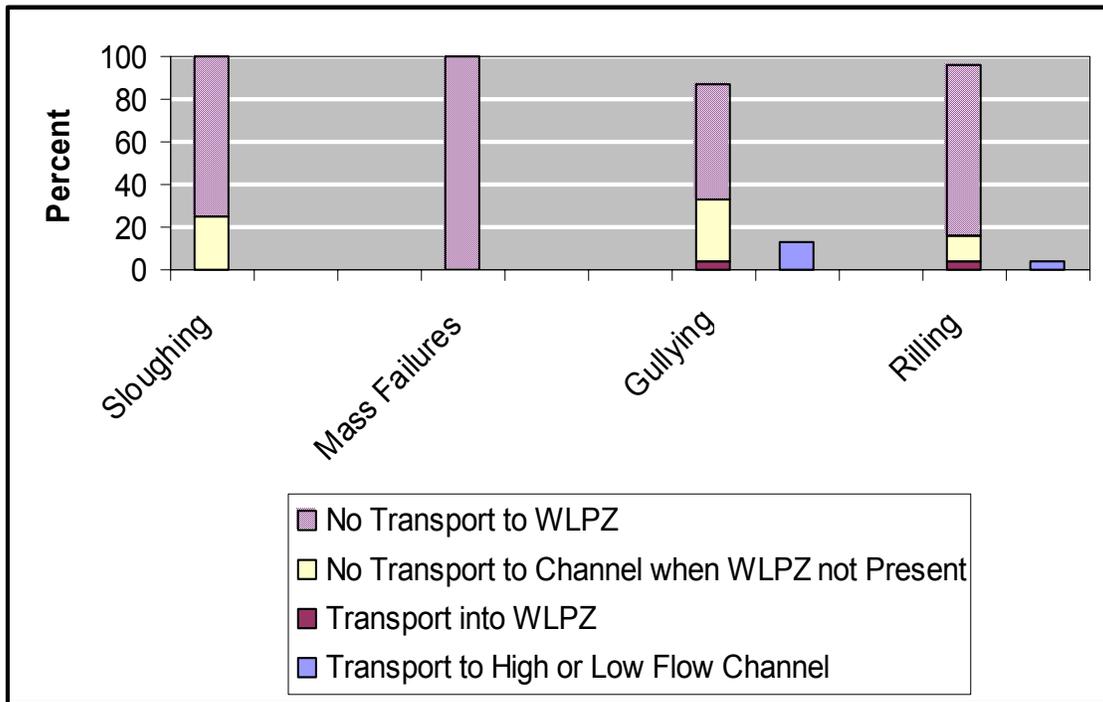
The percentage of inventoried skid trail erosion features related to current operations that had dry season evidence of sediment reaching the high or low flow channel of a watercourse is shown in Figure 10. The percentages of sediment delivering features for sloughing, mass failures, gullying, and rilling features are 0, 0, 13.0, and 3.8 percent, respectively. Sediment delivery data was not reported for 8.3 percent of the rilling features, 2.1 percent of the gullies, 14.3 percent of the mass failures, and 0 percent of the sloughing events. No sediment was transported to the channel from any of the sloughing features or mass failures, 87 percent of the gullies, and 96.2 percent of the rills. For gullies that delivered sediment, 83.3 percent delivered sediment to Class III watercourses. All of the sediment delivered to channels from skid trail rills went to Class III watercourses. The proportions of erosion features delivering sediment from skid trails are considerably lower than that reported from similar types of erosion features found on the road transects (Figure 9).

Figure 10. Percent of erosion features with dry season evidence of delivered sediment to the high or low flow channel of a watercourse from skid trail transect erosion features related to the current THP or NTMP NTO.

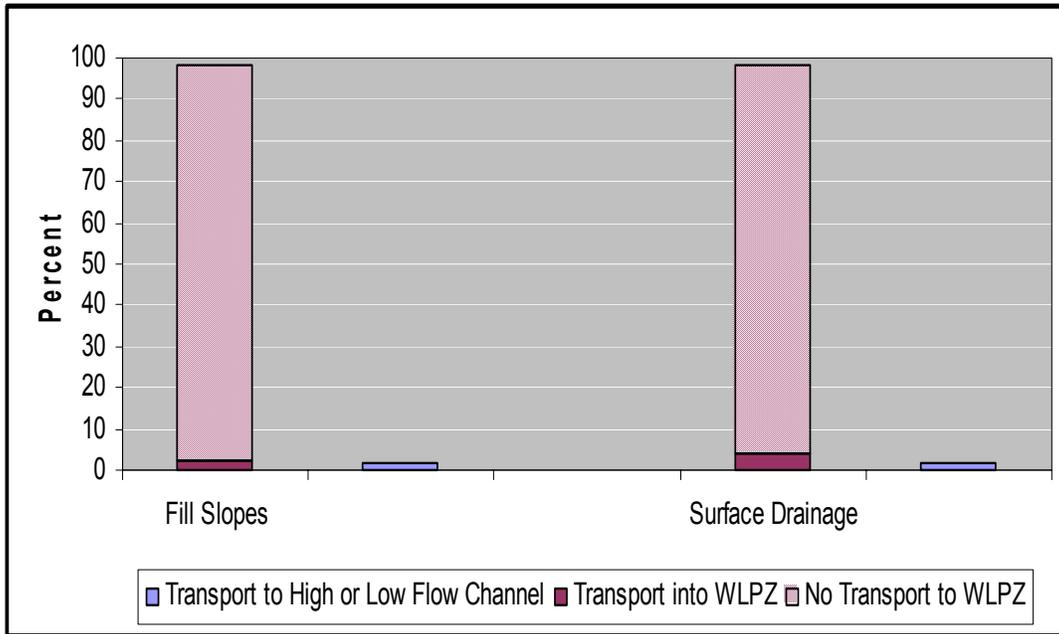
Figure 13. Percent of landing features related to the current THP or NTMP project that had dry season evidence of sediment delivered to either the WLPZ or the high/low flow channel of a watercourse.

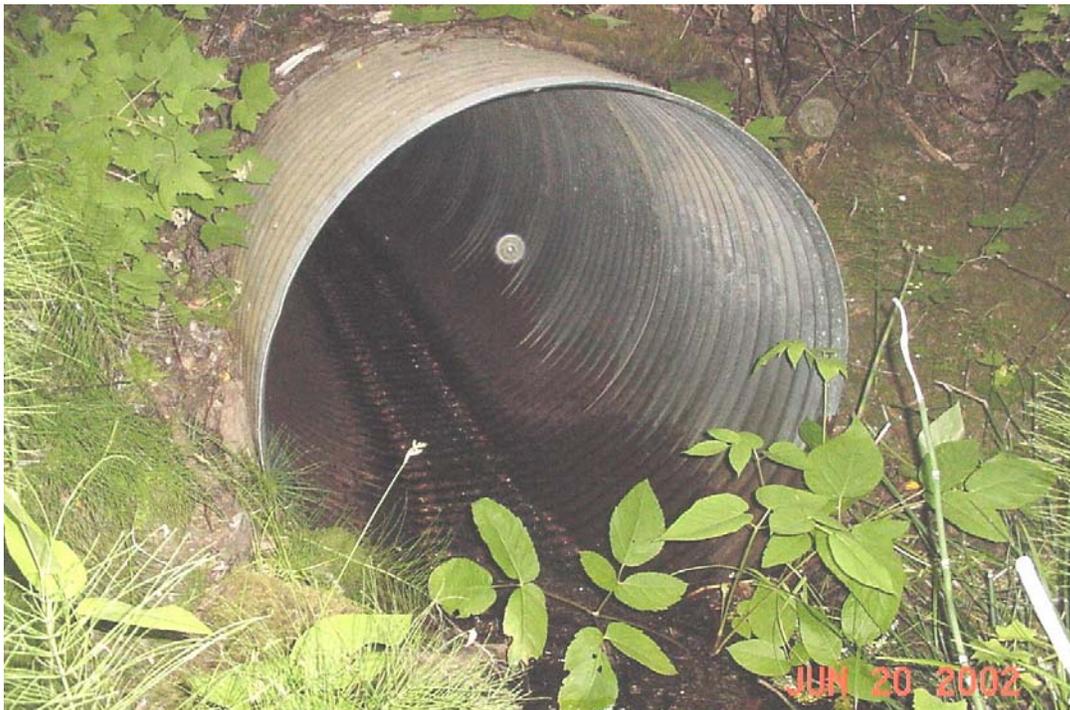
A total of 491 watercourse crossings were evaluated from 1996 through 2001. Approximately 68 percent of these crossings had existing culverts (Figure 14), 12 percent were abandoned or removed road crossings, nine percent were fords, six percent were skid trail crossings, and two percent had bridges (Figure 15). The distribution of culvert sizes is displayed in Figure 16. The majority of pipe sizes are relatively small, reflecting the sampling criteria that favored choosing crossings located along road transects, which were often located above the break in slope near ridgelines. Approximately 64 percent of the crossings were existing road-related structures built prior to the beginning of the current plan; 18 percent were new road features; 12 percent were abandoned or removed crossings for roads; and six percent were removed, existing ford, or new skid trail crossings. Seventy-three percent of the crossings were associated with seasonal roads, 16 percent with permanent roads, four percent with temporary roads, six percent with skid trails, and less than one percent with abandoned roads. Forty-seven percent of the crossings were located in Class III watercourses, 46 percent in Class II drainages, six percent in Class I's, and less than one percent in Class IV watercourses.

Figure 14. Typical watercourse crossing sampled in the Hillslope Monitoring Program. This culvert was a crossing included in the sample for the 2002 field season.

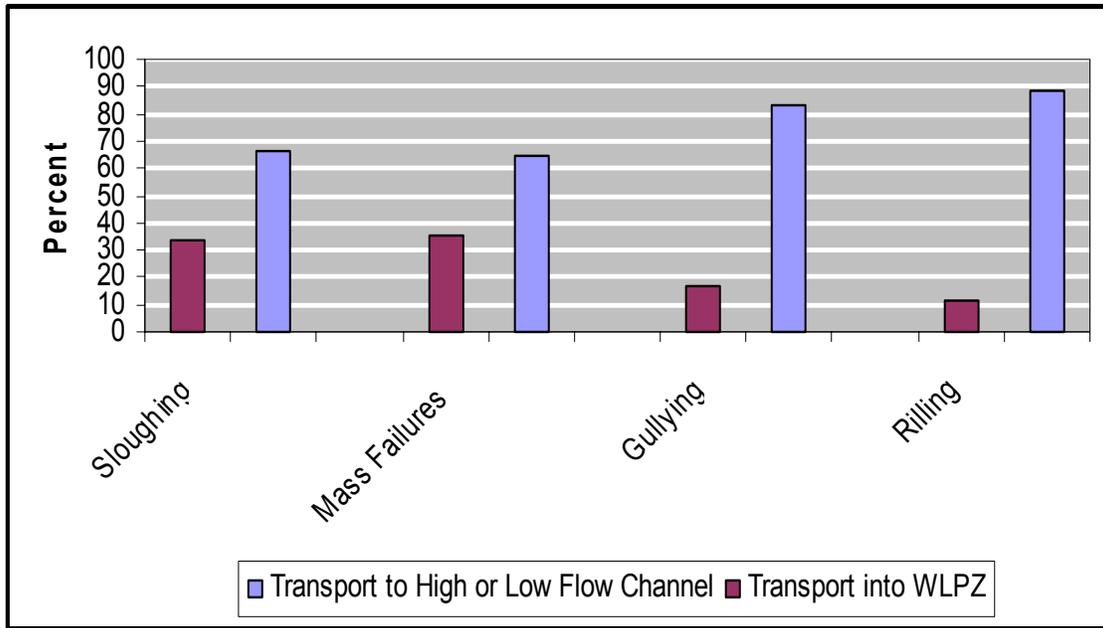
Figure 20. Percent of erosion features with dry season evidence of delivered sediment to the high or low flow channel of a watercourse from watercourse protection zone transect features associated with the current THP or NTMP project.

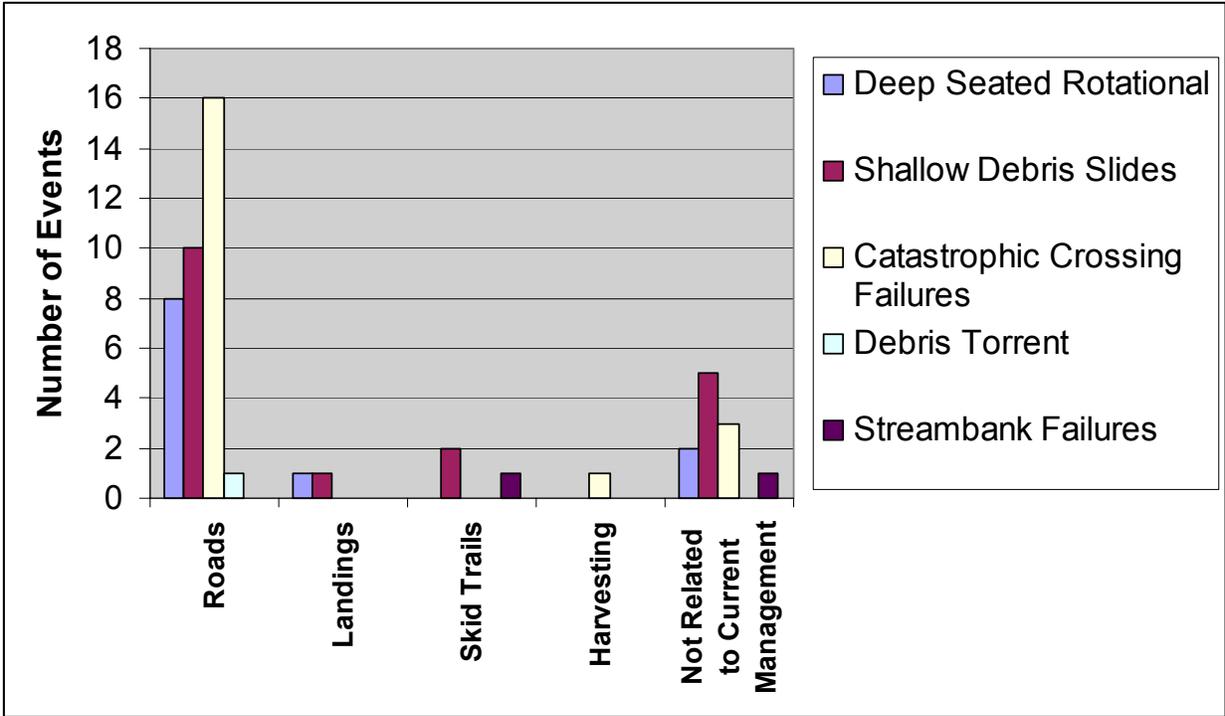
Figure 21. Primary causes of large erosion events and type of feature (note that multiple causes were assigned in some instances).

features, 39 were classified as being related to current timber management activities (Figure 21).

Most of the inventoried large erosion events related to management activities in the current plan were associated with roads (35), with smaller numbers of events associated with skid trails (3), landings (2), and harvesting (1). Cause codes and associated features are displayed in Figure 21, while specific cause codes are shown in Table 38 (multiple cause codes were assigned in some instances, so the total is greater than the 39 events). The most frequent causes of management related large erosion events were: cutbanks with slope support removed; subsurface water concentration;
