SNUFFINS CREEK

STREAM SURVEY - SNUFFINS CREEK

NAME OF STREAM - Snuffins Creek COUNTY - Mendocino

EXTENT OF OBSERVATION - Surveyed on June 9, 1966. Four hours were spent making the survey. Survey made by John L. Thomas, Fishery Biologist II. Survey made on foot.

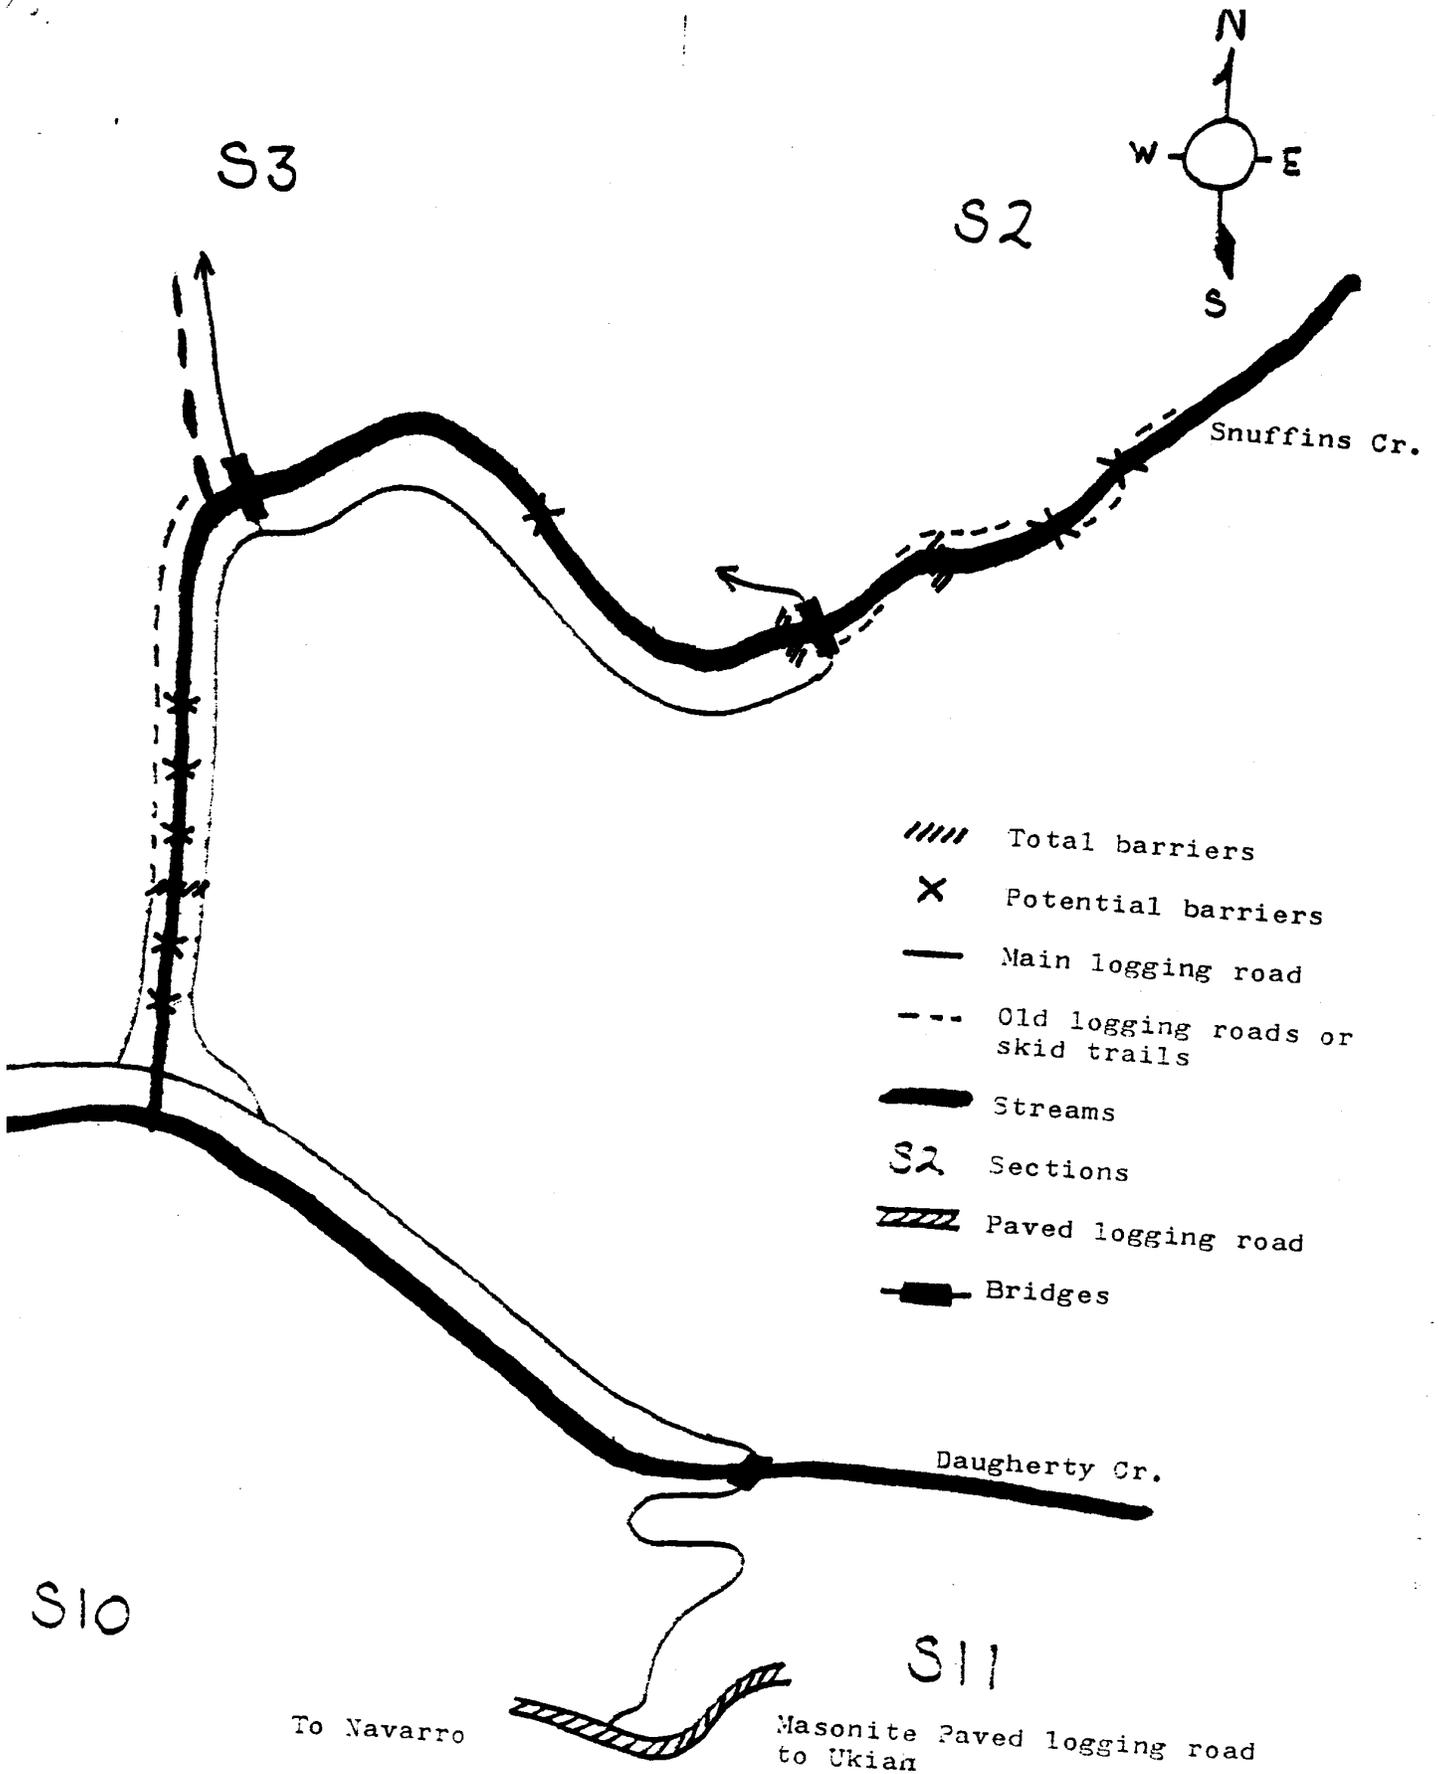
BARRIERS - There are at least five log jams from the stream mouth to the first total barrier to upstream migration. The first total barrier is 0.1 mile above the mouth of the stream. All jams below are spaced 50 to 100 feet apart, the first jam being 100 yards above the mouth. The first 5 or so jams are not barriers at present, but they will probably silt in during next winters rain. There are several small log jams passible at present to fish above the first total barrier. However, there is another total barrier located at the second bridge crossing (Location just under the "i" in the word "Snuffins" on the 1959 Boonville U.S.G.S. quadrangle in T15N, R14W, S3). This barrier is a log 12" thick braced across the stream with heavy load of debris and silt behind. There is a 4 foot drop to the pool below with no good access for adult steelhead passage. There is a similar barrier 100 feet above the bridge. Small log jams are very common above the bridge; however, most at present look passable.

POLLUTION - Severe logging damage with roads paralleling stream on both sides the first mile, and along one side the first 1 1/2 miles. There is a very large amount of slash and short cut pieces of redwood in the main stream channel forming semi-permanent and permanent barriers to fish passage. The roads and nearby skid trails are being eroded and filling in behind the log jams.

IMPROVEMENTS - The entire drainage is in need of improvement. Erosion should be checked where possible. Possibly the planting of fast growing alder or willow should be made along the stream to hold bank erosion and offer streamside shade to reduce water temperatures. Further, the slash should be removed from the stream channel. All log jams should be removed, and single logs causing barriers by backing up silt and creating impassable falls should be removed. There are at least 10 problem log jams between the stream mouth and the second bridge. Two of these jams are considered total barriers.

RECOMMENDED MANAGEMENT - This stream should only be managed for steelhead. Habitat improvement is the recommended management. The first step would be the removal of all log jams and barriers. Second, erosion should be checked where possible. This could be done by seeding with grasses, or planting of willow and alder along the stream to stabilize the stream banks, and at the same time offering streamside shade which would reduce water temperatures and inhibit algae growth. Meanwhile, fry should be netted from the stream near the mouth and planted above the barriers to cause less reduction in the 1966 year class. This would spread the nursery area over a 2 1/2 mile area instead of only the first 0.1 mile. Water requirements are at a minimum now to support the existing fishery. It is suggested that no water be diverted from this stream from May through December.
