CALIFORNIA DEPARTMENT OF FISH AND GAME

STREAM SURVEY

NAME...Dago...Creek.....COUNTY...Mendocino.....

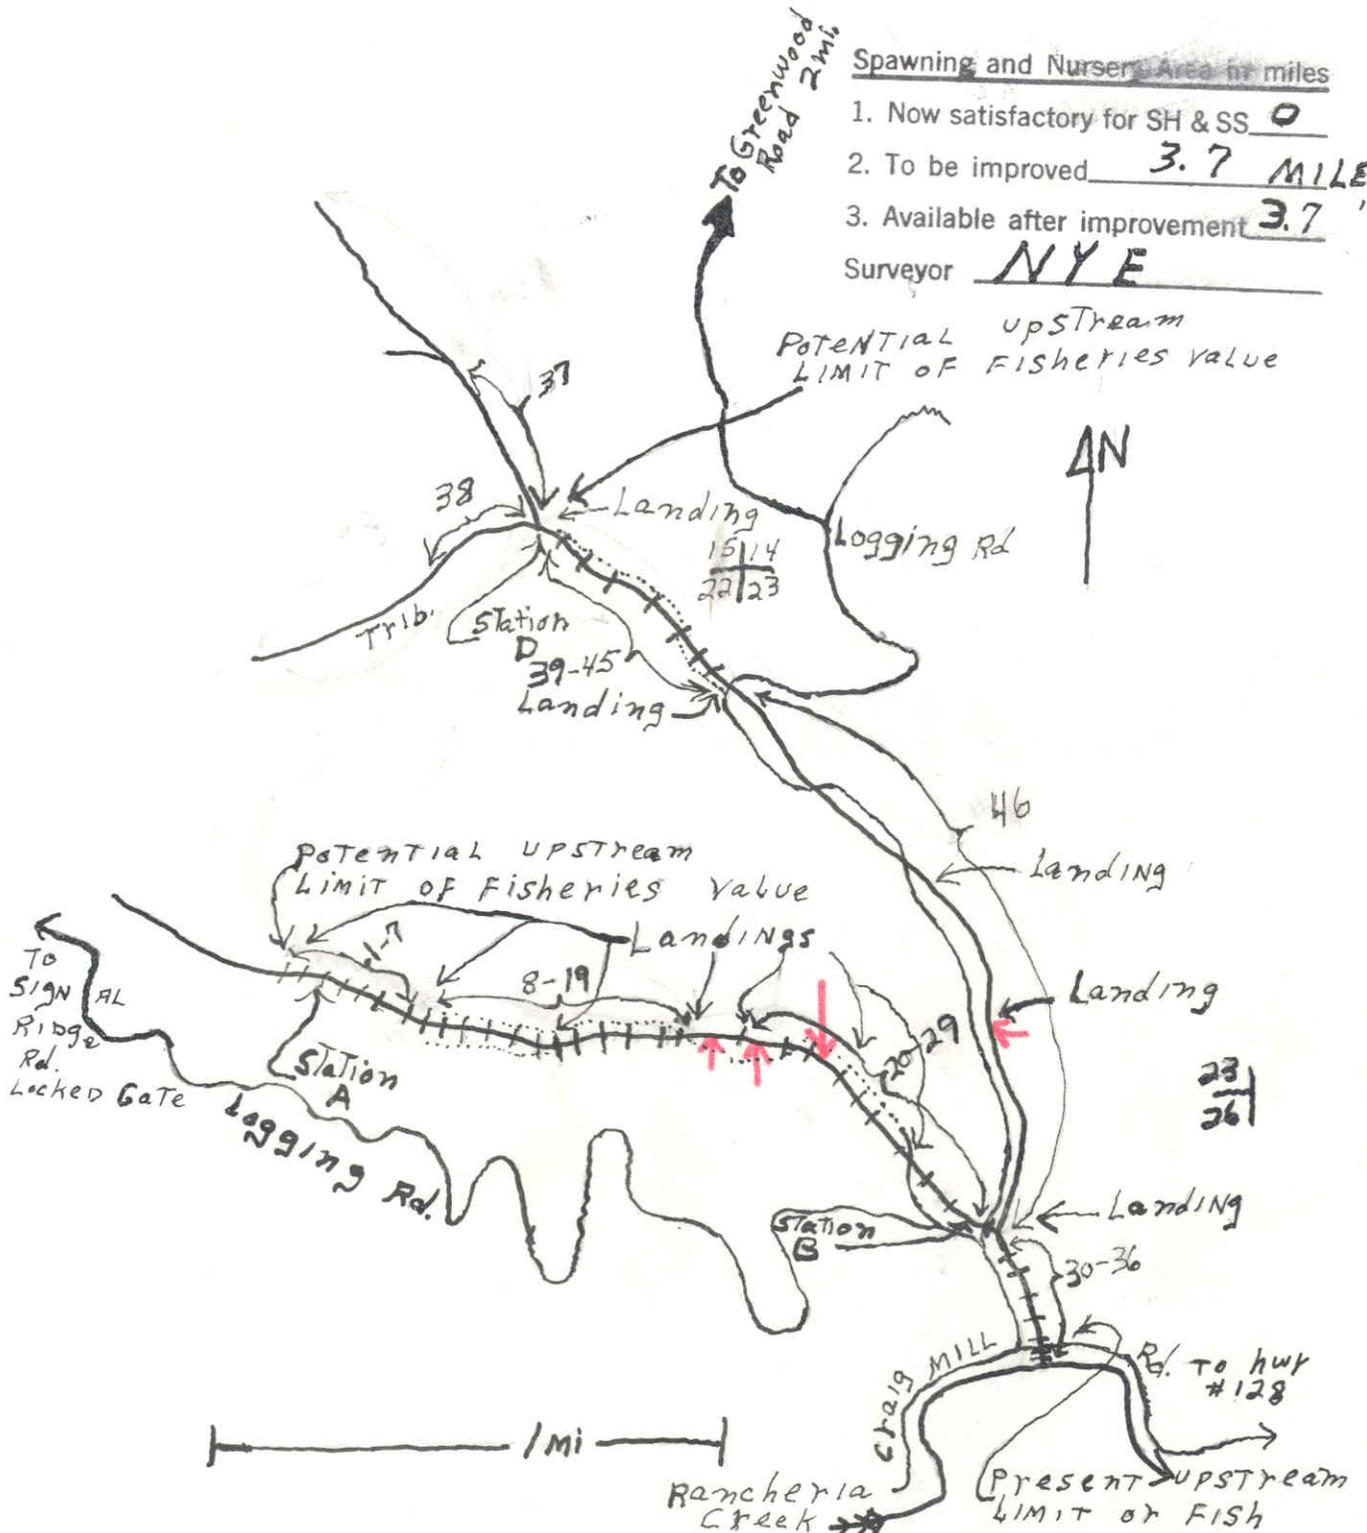
# Dago Creek

Spawning and Nursery Area in miles

1. Now satisfactory for SH & SS 0
2. To be improved 3.7 MILES
3. Available after improvement 3.7 "

Add 2% For debris between Jams NOT LISTED
