Fluvial Geomorphic Response Of a Northern California Coastal Stream To Wildfire

Laurel M. Collins¹ and Brannon Ketcham²

2001

Fluvial Geomorphic Response of a Northern California Coastal Stream to Wildfire

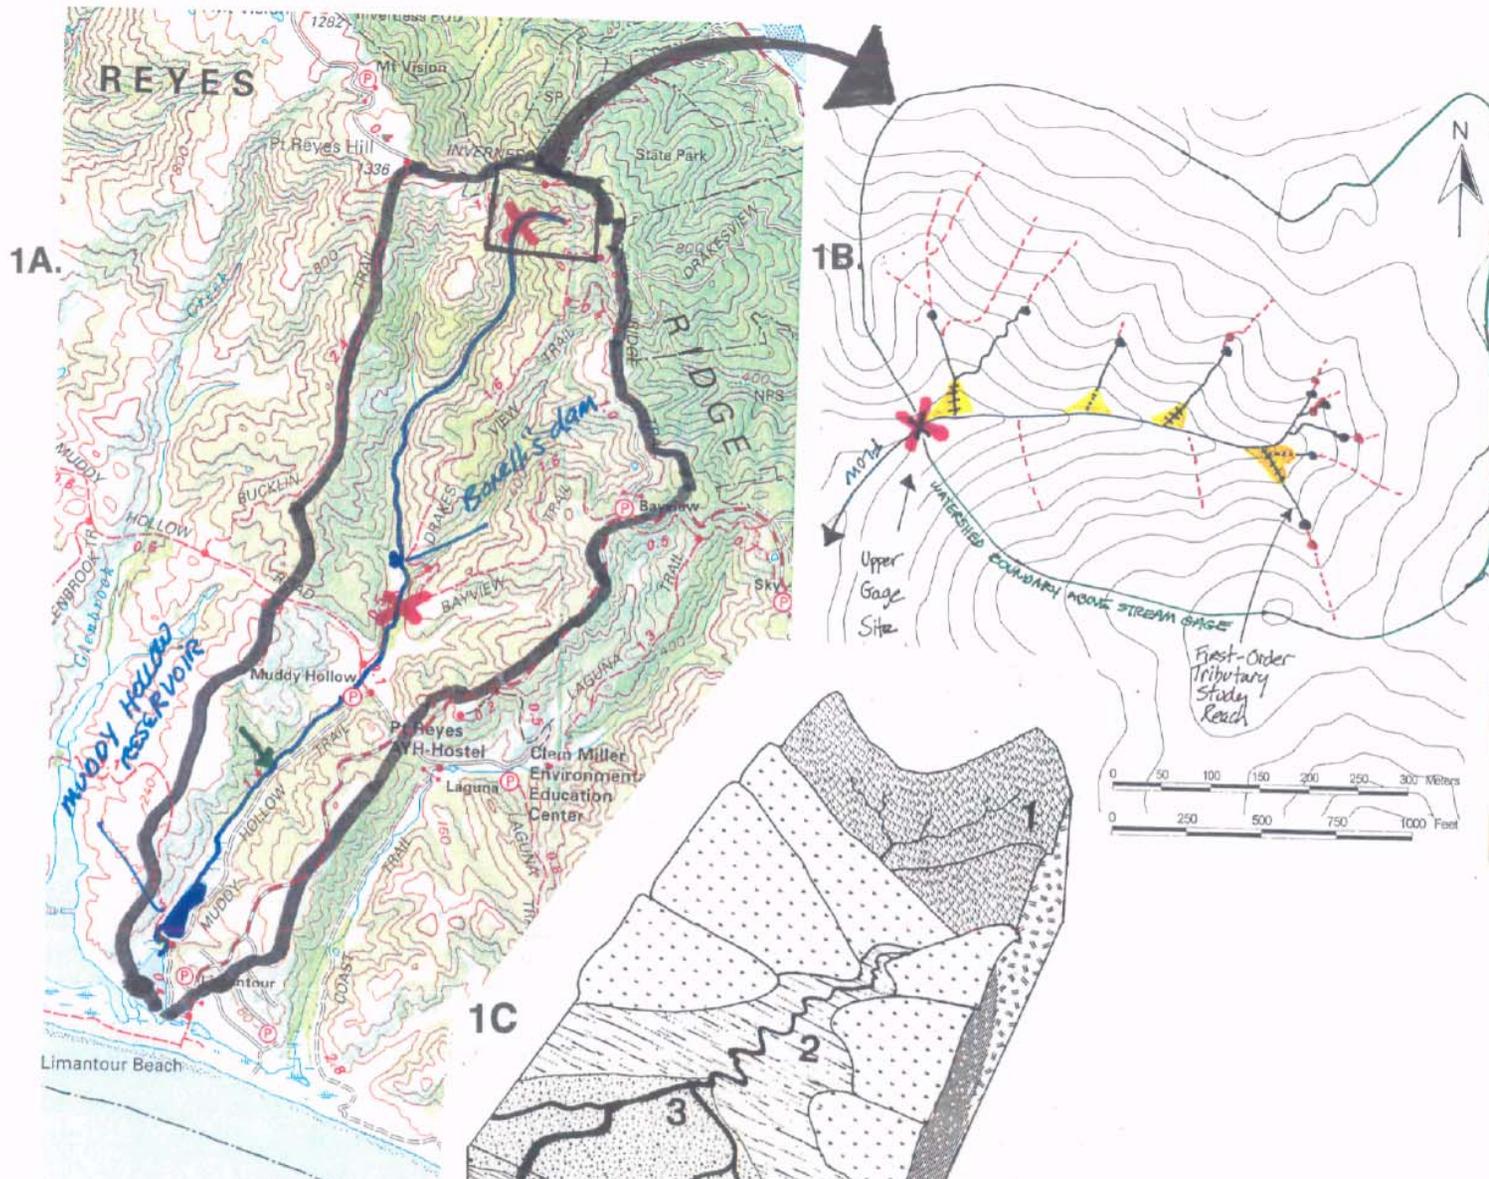
Figure 1. A) The boundary of Muddy Hollow the watershed shows the Upper Gage Site location. The Green arrow near the bottom of the alluvial fan during spring of 1998. B) A detail of the dashed lines represent rills that developed after the fire along show the original location of channel heads , while red dots show alluvial fans that became channelized after the fire, while dotted blue lines show alluvial fans that did not become channelized. Yellow area show alluvial fans at the base of steep tributaries. C) A conceptual diagram of the watershed is shown where point 1 represents the Upper section, point 2 represents the Middle Section, and point 3 represents the Lower Section as indicated by the alluvial fan.

Reservoir is outlined in black. The red X at the top of the watershed shows the location of the apex of the Upper Watershed Section is shown. Red the main axis of zero-order basins. Blue dots show their post-fire location. Hatched blue lines show alluvial fans at the base of steep tributaries. Yellow area show alluvial fans that became channelized after the fire, while dotted blue lines show alluvial fans that did not become channelized. A conceptual diagram of the watershed is shown where point 1 represents the Upper section, point 2 represents the Middle Section, and point 3 represents the Lower Section as indicated by the alluvial fan.

The study was designed to provide an understanding of the overall response of the landscape to fire. We developed an approach to provide both wide spread reconnaissance of different morphologic sections of the watershed, and detailed monitoring of representative stream reaches. Based upon stream gradient and valley conditions, the watershed along the mainstem MHC was conceptually divided into Upper, Middle, and Lower Sections (Figure 1C).

The channel head locations of first-order streams throughout the Upper Section were mapped before the onset of winter rains. These channels were all spring fed by perennial flow. They are shown as blue dots in Figure 1B. Following the first post-fire year, the channel heads were remapped because increased runoff had caused most of them to extend headward. The new locations are shown as red dots. The dashes represent the headward extent rills that went up the main axis of the hollow. These will most likely be ephemeral features that disappear after vegetation recovers and a litter layer develops.

A first-order tributary was selected to monitor in detail. Its location (shown with black arrow in Figure 1B) was near the top the drainage. The channel was initially disconnected from the mainstem by an unchannelized alluvial fan. A portion of its middle reach was actually a short subterranean tunnel. Its changes in gradient are shown in Figure 3 for four different time periods: early November 1995 before rainfall; first post-fire mid winter (1/20/96); end of first post-fire year rainy season (2/26/96); and end of second post-fire year rainy season (10/1/97). Overall, the channel gradient of about 33% remained the same. The profile shows consecutive episodes of relatively parallel downcutting by as much as 2.1 m (7 ft), but averaging about 1 m (3.2 ft). The pre-fire average depth of the channel was about 0.6 m (2 ft) and a thin veneer of alluvium covered the bed. The post-fire channel became deeply entrenched by excessive amounts of runoff

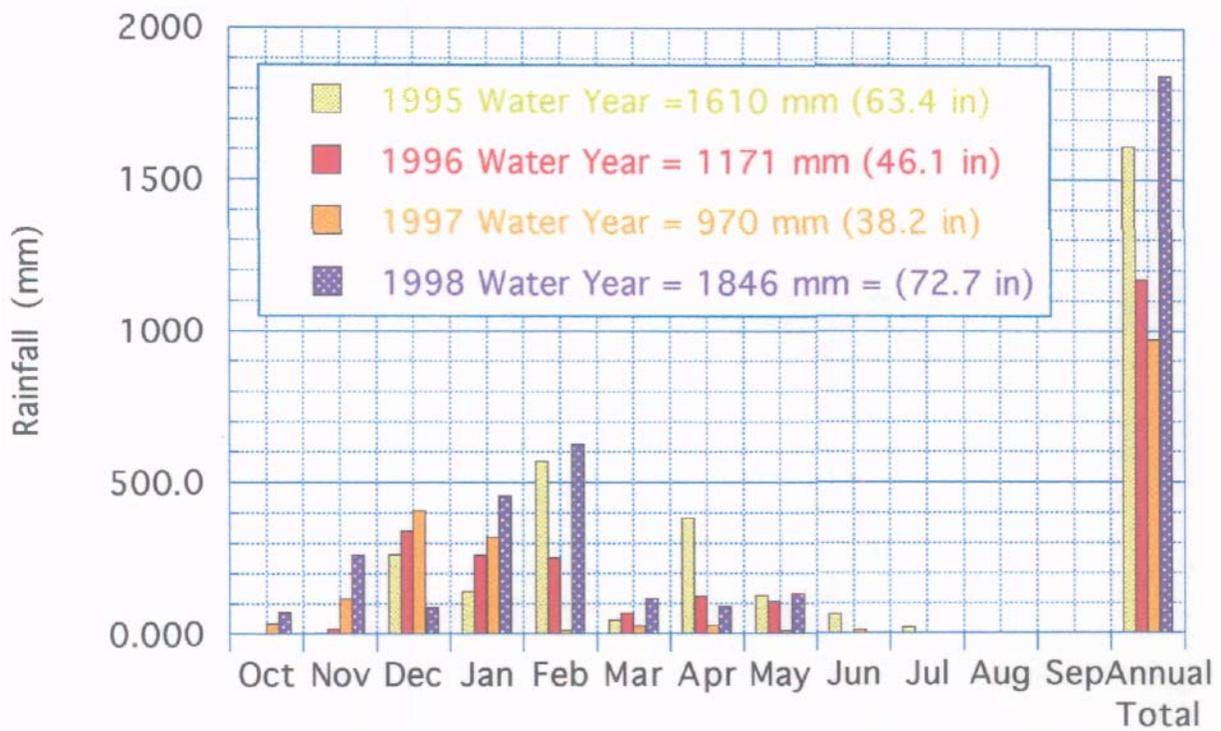
Monthly Rainfall at Bear Valley Station Point Reyes National Seashore

Figure 2. Monthly rainfall totals are shown for the Bear Valley Ranger Station. Water Year 1995 was before the Vision Fire. If the mean annual total for the area is 1,016 mm (40 in), then three of these four years had above average rainfall. The El Nino year of 1998 had 182% of normal rainfall.

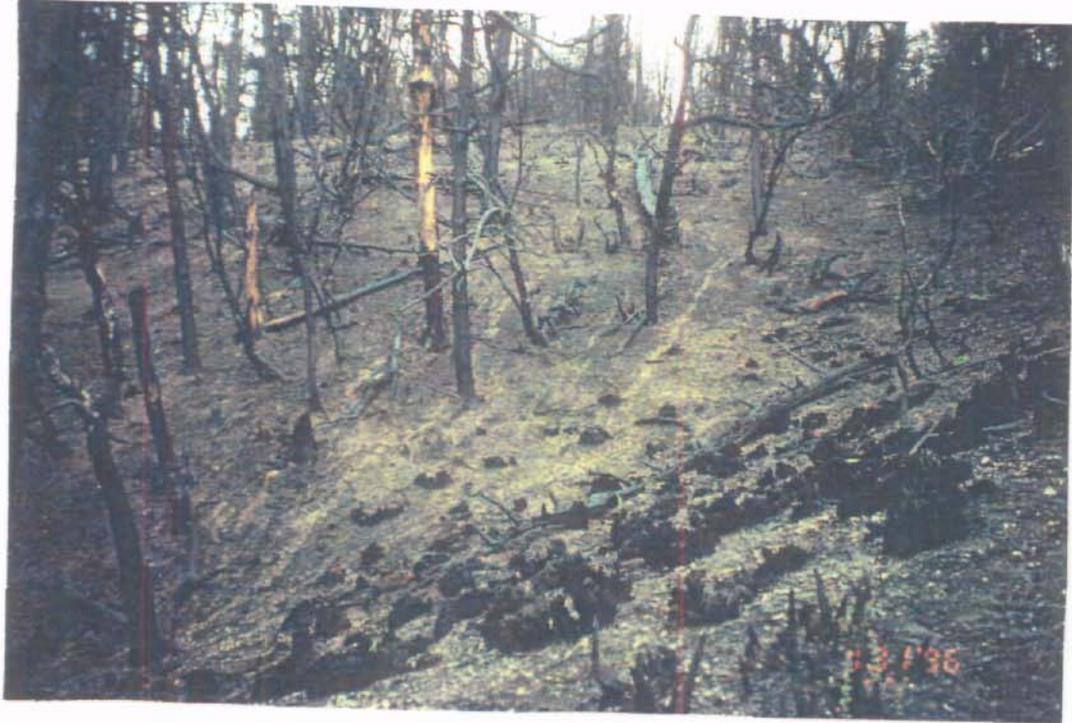
Photo 1. The Upper Watershed Section is shown for January 16, 1996. Light-colored trails mark areas of rilling where ash has been removed by overland flow.

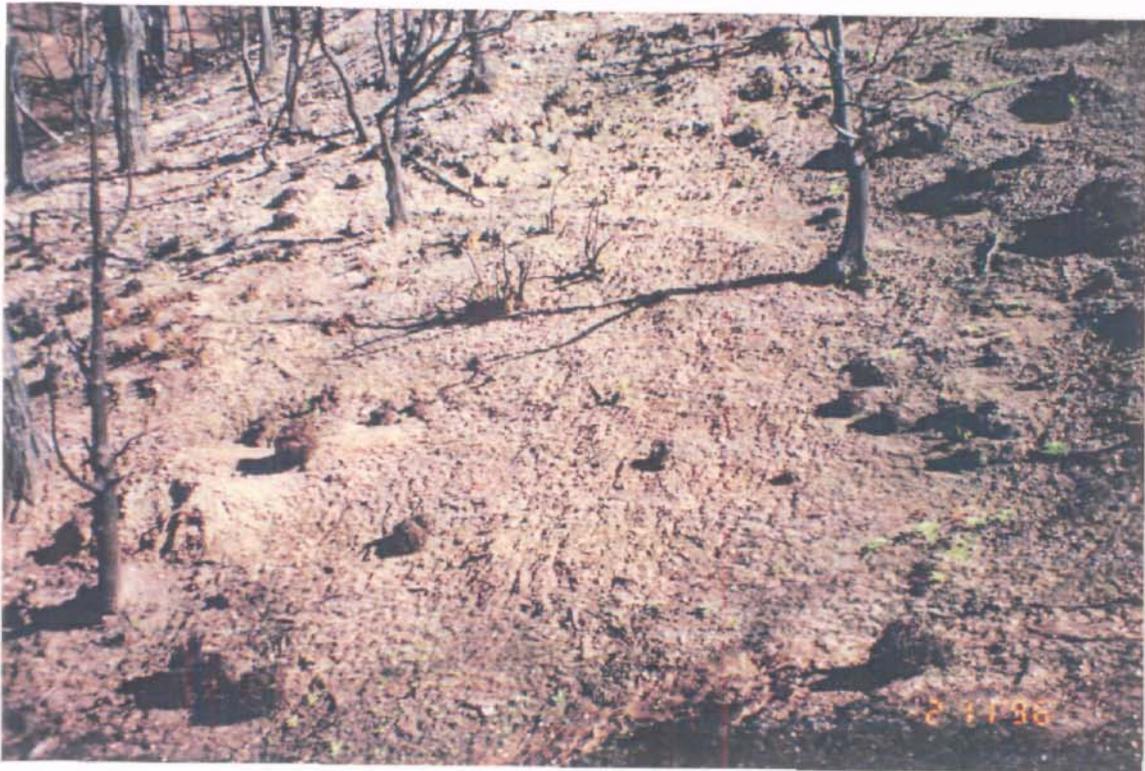
Photo 2. The same general vicinity of the Upper Watershed Section is shown for February 11, 1996. An extensive network of rills has formed and much of the ash has been displaced.

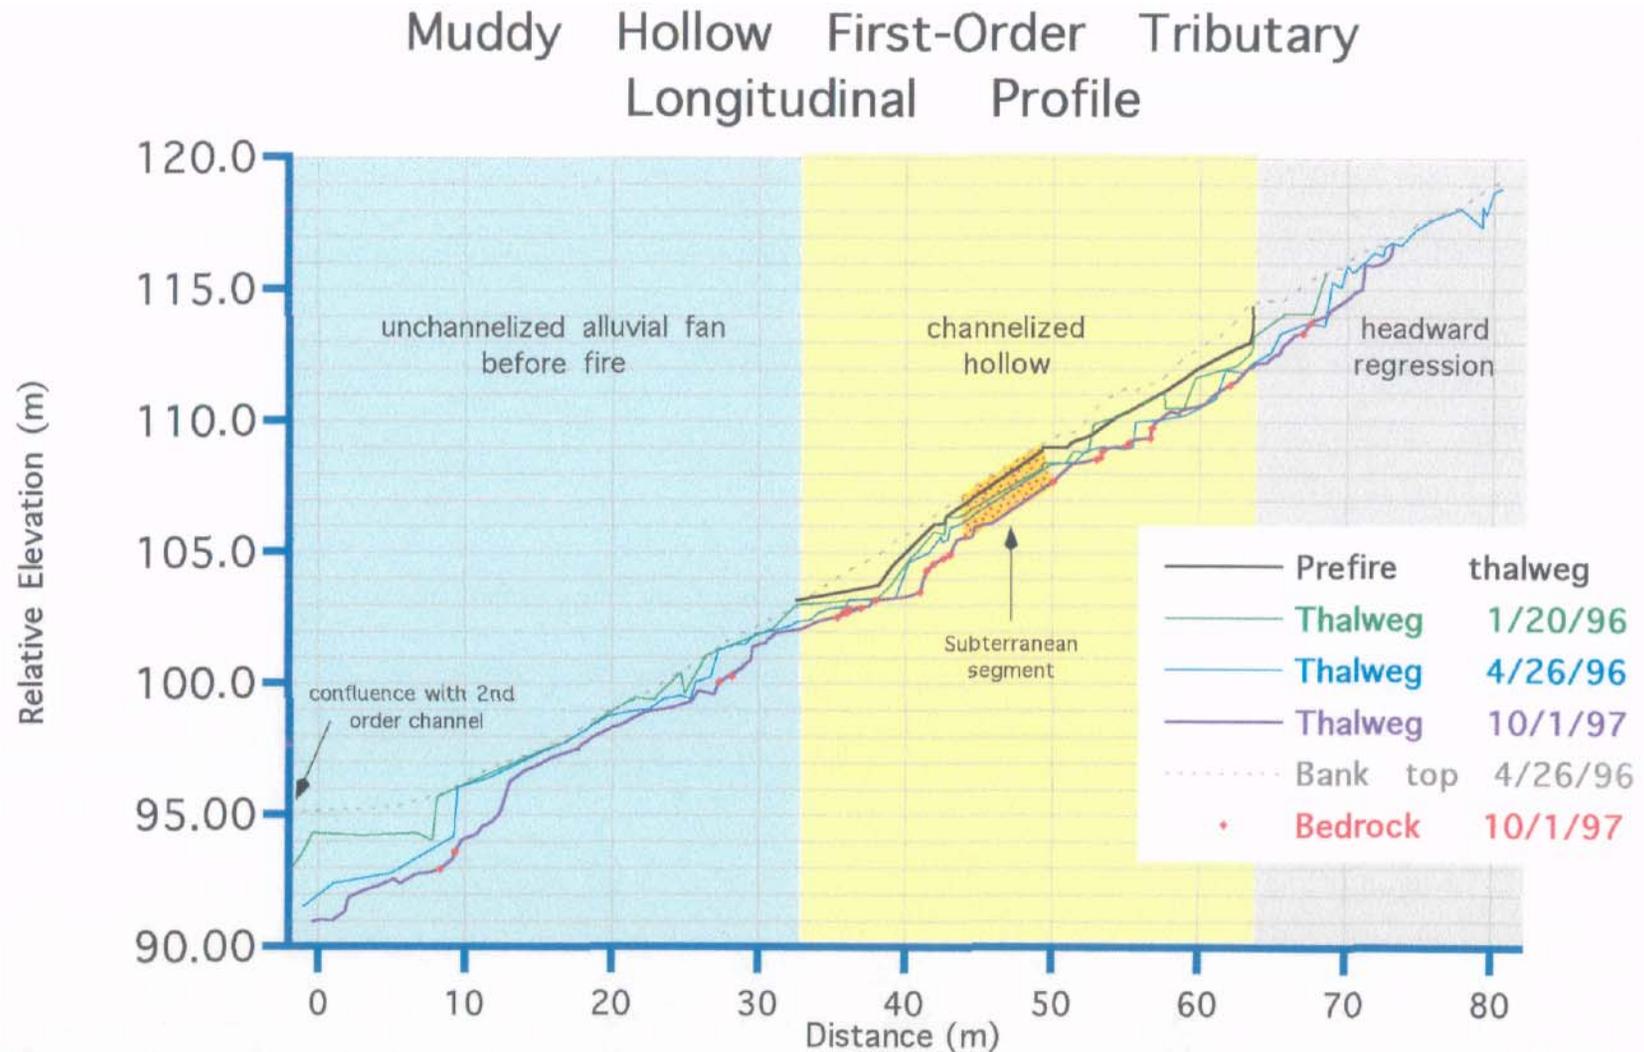
Figure 3. Repeated longitudinal surveys are shown for the First-order Tributary that is shown in Figure 1B. Before the fire, transport of water and sediment to the mainstem channel was inhibited by the alluvial fan.

carving the slightly to moderately weathered and fractured granitic bedrock. Deposition was insignificant. The channel head has extended upstream about 7 m (22 ft), while the ephemeral, main axis rill extended another 76 m (250 ft). Photos 5 and 4 show the changes near the channel head between pre-runoff conditions and three months later.

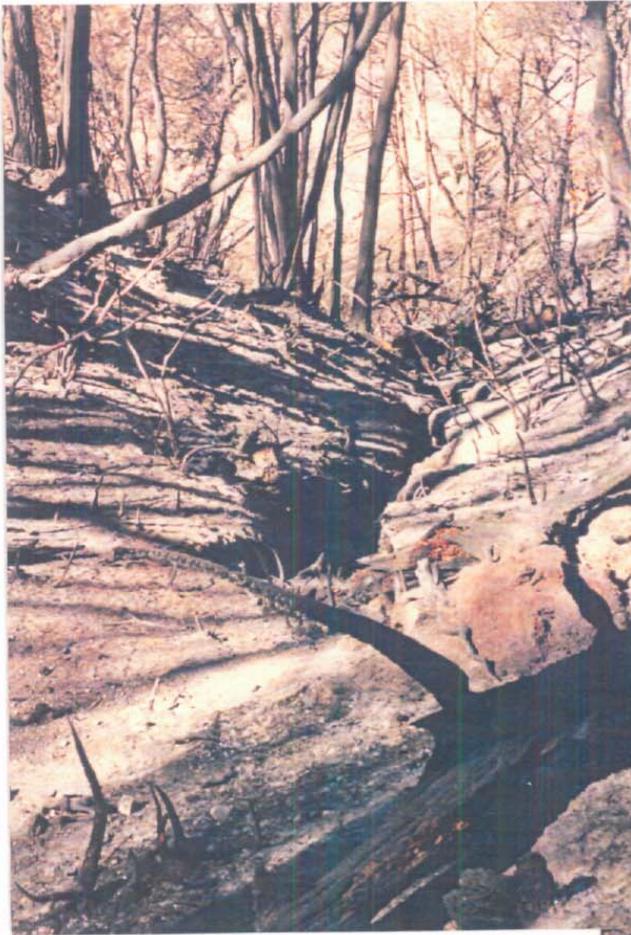
Photo 3. The head of the First-order Tributary that was surveyed in detail is shown for early November 1996, before post-fire rainfall influenced the site. The channel had a trickle of perennial flow. Average depth was about 0.6 m (2 ft) and average width about 0.3 m (1 ft).

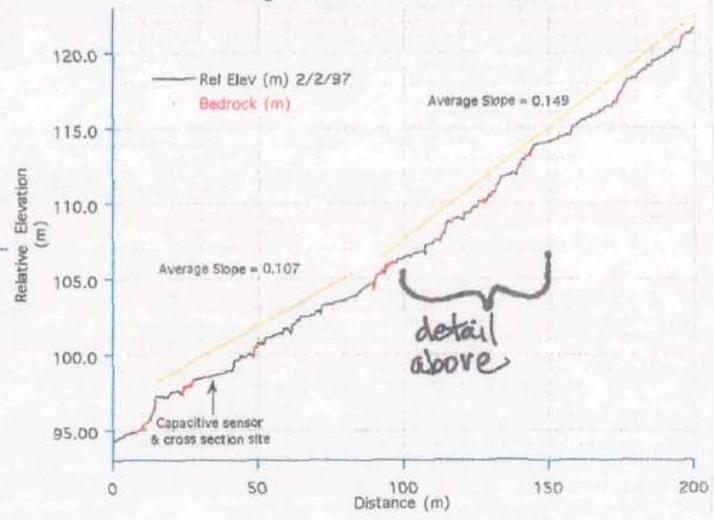
Upper Muddy Hollow, Third-order Mainstem Longitudinal Profile 9/1997

Figure 4. A detail (large graph) of net erosion and deposition is shown for 50 m (164 ft) of the 200 m-long (656 ft) profile (small graph) of the third-order Muddy Hollow mainstem.

The longitudinal survey of the third-order channel was conducted along 200 m (656 ft) of channel. The lower half was resurveyed four times, the upper half was surveyed twice. Most all the sediment that was mobilized in the headwaters was transported through the entire Upper Section. Through the surveyed longitudinal profile reach, only a minor amount of sediment accumulated on 15% of the channel length. Trapping behind small woody debris was usually the cause. At one short site the maximum depositional thickness was 0.58 m (1.9 ft). The remaining 85% of the channel eroded, leaving 50% of its length as exposed bedrock. Average incision depth was about 0.17 m (0.6 ft), but ranged up to 0.46 m (1.5 ft). Most of the erosion took place during the first rainy season.

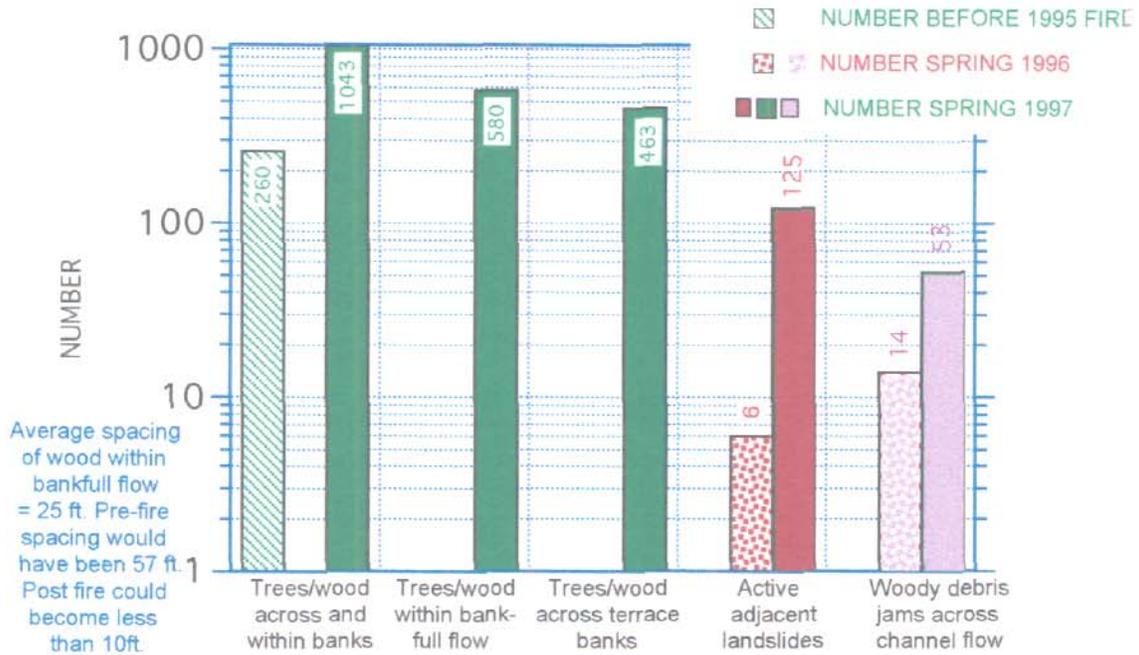
Figure 5A. Pre- and Post-fire Woody Debris, Slides and Debris Jams along MHC Middle Watershed Section

Figure 5. A) The amount of woody debris before and after fire is shown. Of the 1,043 woody debris elements influencing the channel, 86% are alders. The amount of slumps and debris jams are also shown for the second two years. B) The way that woody debris is recruited to the channel is shown. For wood listed as floated, its method of recruitment could not be determined.

During the first 1996 spring reconnaissance of MHC mainstem, the number of active landslides and debris jams were quantified as we walked down the channel. The amount of large woody debris (LWD) that was in the channel before the fire was possible to quantify because it did not have burn scars. During the second spring in 1997, landslides, and debris jams were recounted. Additionally, the location of LWD was noted as to whether it was in the channel bed or across the banks. This was important to note because the channel throughout the Middle Section was generally moderately to deeply entrenched, meaning that only high flows would intercept the wood across the banks or it would not be intercepted until it decayed or warped. The results of the reconnaissance are shown in Figure 5A.

The amount of LWD that was in the channel and/or across the banks increased from 260 elements from pre-fire 1995 conditions to 1,043 elements in 1997. The 1995 wood spacing was 17.3 m (57 ft) over the 4.5 km (2.8 mi) Middle Section. Of the 1997 total of 1,043 wood elements, 86% were alders and most were whole tree trunks. About 10% were elderberries. The remainder included (in order of importance) bay, willow, oak, and juniper. About 56% (580 elements) of the total amount of 1997 LWD were in the active channel bed. This created an average 1997 LWD spacing of 7.7 m (26 ft). The remaining 44% of the total number of LWD had fallen across the channel banks. By the third 1998 spring, many of the alders that were across the banks started to bend into the channel or broke apart and fell into the active bed. Thus, a conservative estimate of the change in LWD spacing by 1998 or 1999 would be less than 3 m (10 ft). Between 1996 and 1997 the number of woody debris jams also increased from 14 to 53. There was no indication that there were existing debris jams before the fire. This number will likely increase as the large alders break into transportable sizes.

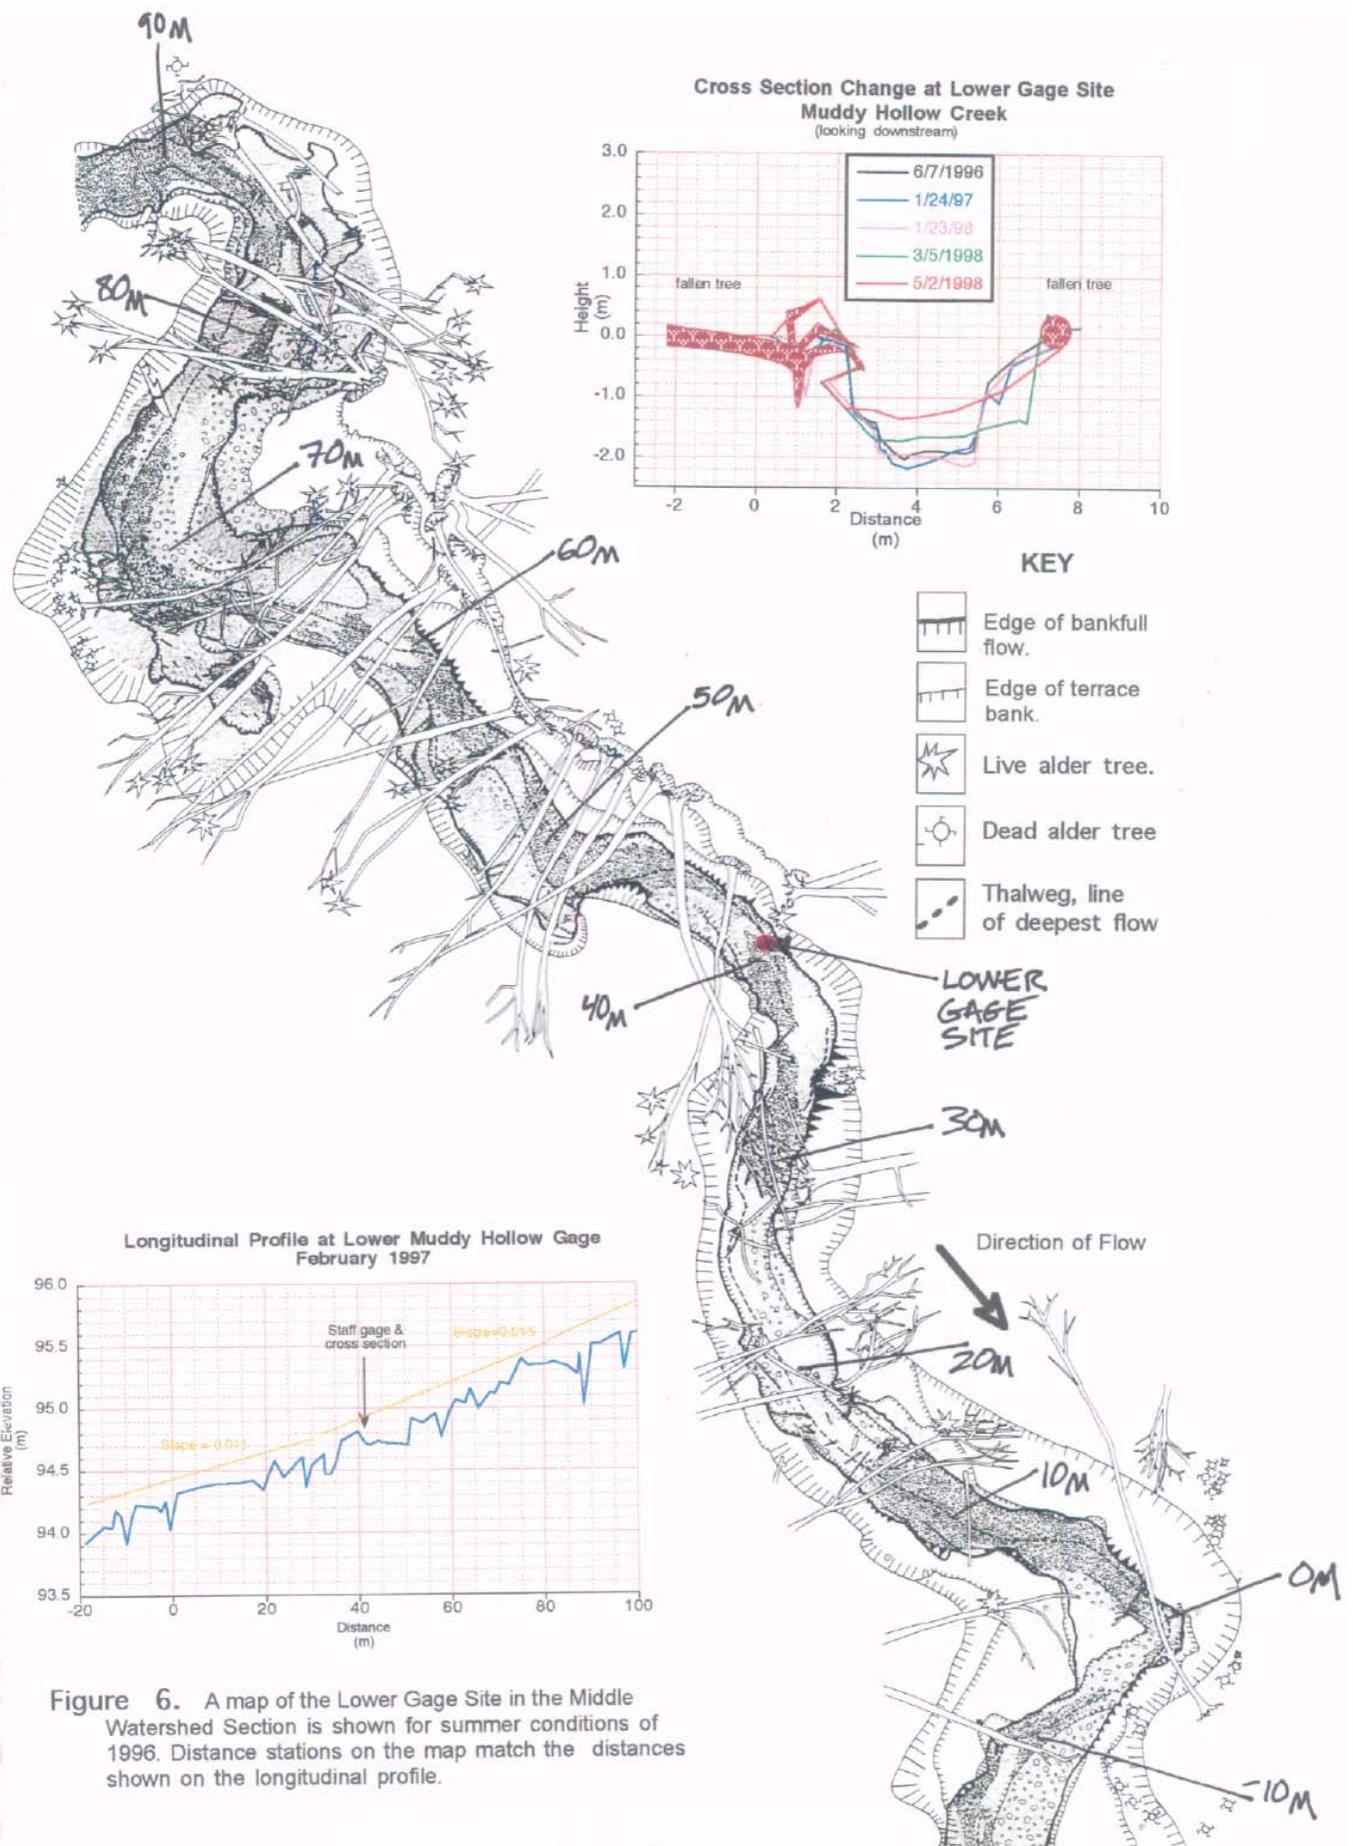
Figure 6. A map of the Lower Gage Site in the Middle Watershed Section is shown for summer conditions of 1996. Distance stations on the map match the distances shown on the longitudinal profile.

The cross section at the upper right corner of Figure 6 shows the changes in width and depth that occurred near the gauge site between June 1996 and May 1998. The cross section before fire was not expected to be much different from that shown for 1996 because no significant erosion was observed at the site at the time of the survey. The amount of cross sectional change prior to the 1998 February flood flow of the El Nino year was about 0.2 m (0.7 ft) of incision followed by the same amount of deposition. During the February flood, when high flows started to intersect much of the LWD, the banks widened by nearly 1.5 m (5 ft). The bed elevation increased in height by another 0.3 m. At the end of the rainy season the bed averaged about 0.7 m (2.3 ft) higher than its 1996 elevation. These changes were due to the effects of wood in slowing the water velocity, trapping the sediment, reducing the channel gradient, and creating obstructions to flow that increased local sediment supply.

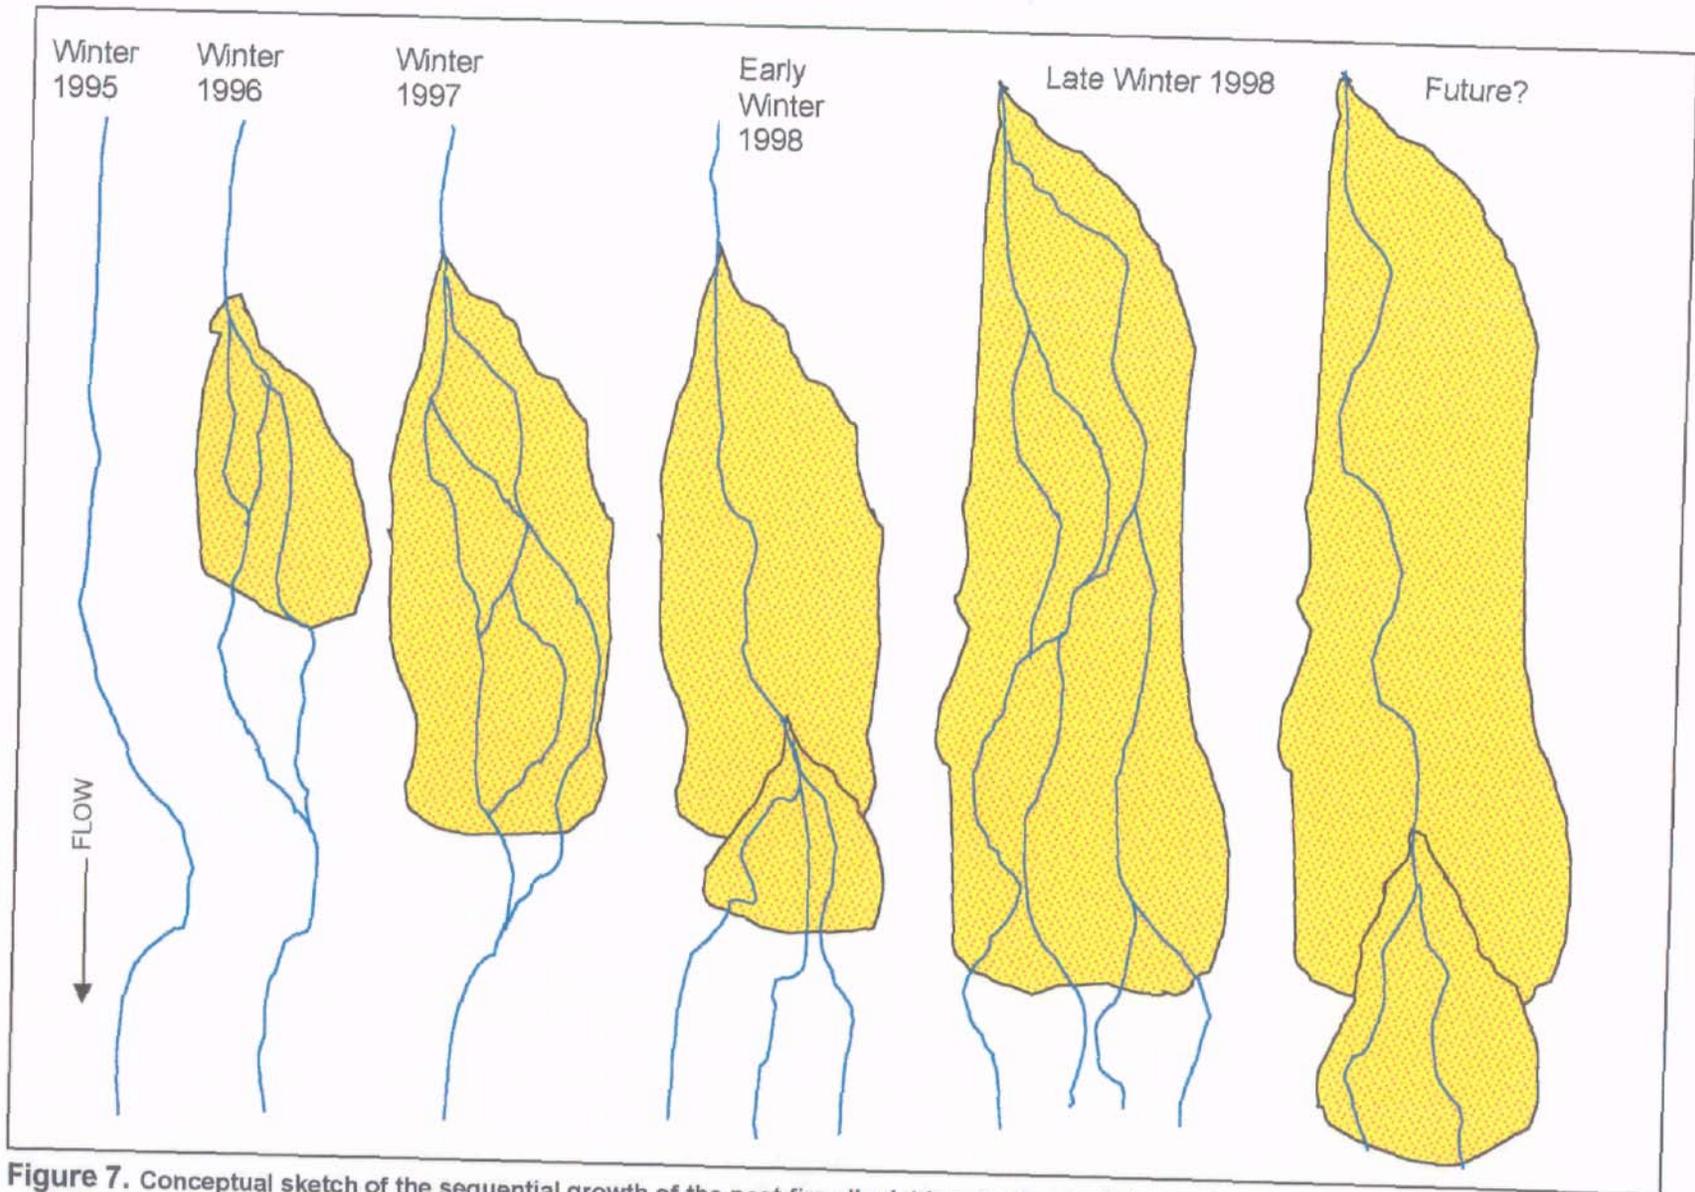
Figure 7. Conceptual sketch of the sequential growth of the post-fire alluvial fan upstream of Muddy Hollow Reservoir. When the sediment supply is high, the alluvial fan grows as the channel braids and separates into distributaries. When the sediment supply from upstream fluvial transport decreases, a single thread channel incises and reworks sediment in the fan and deposits a new fan downstream.
