Analysis of the
1998 Garcia Estuary Cross Sections
by
Dennis Jackson

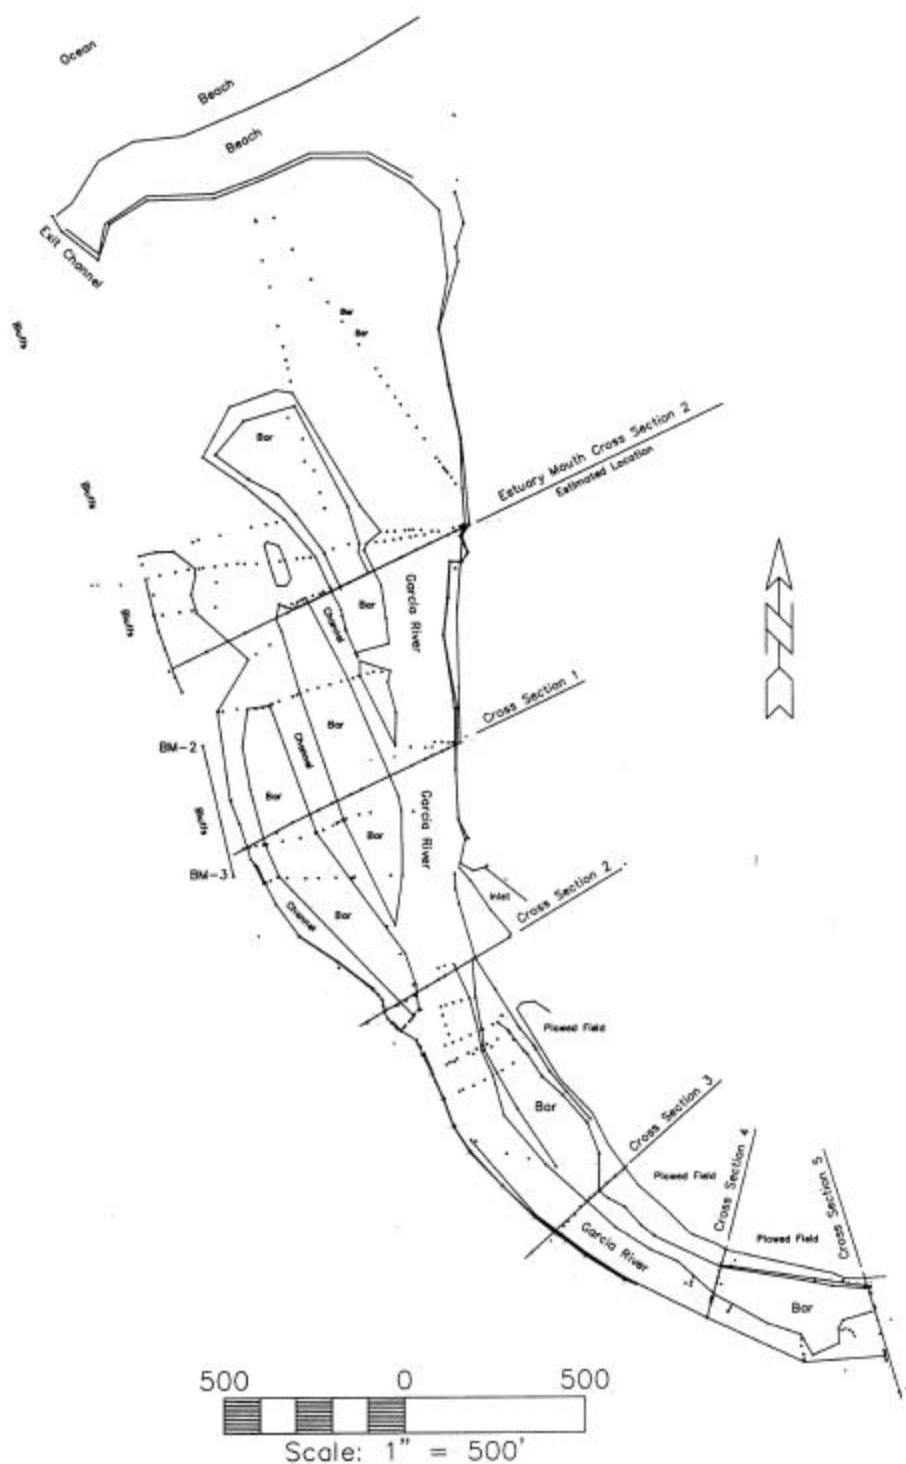
Figure 1. Map of Garcia River Estuary showing the points between cross sections. Lines connecting points are topographic break lines.

In October of 1998, Dennis Jackson surveyed five of the six cross-sections that were surveyed by Scot McBain in March of 1995. A substantial number of ground shots were also taken between the cross sections, see Figure 1. The sixth cross section, Estuary Mouth Cross Section 2, was not directly surveyed because neither endpoint stake could be located. A line was surveyed at the approximate location of the missing cross section. The 1991 field notes were used with the 1995 coordinate system to improve our field estimate of the location of the Estuary Mouth Cross Section 2. The missing cross section was then estimated from ground shots that were taken nearby.

Numerous ground shots were taken between the cross sections. Shots were taken along the edge of water of the estuary and the adjacent top of bank. These ground shots will be invaluable in assessing changes in the extent of the estuary. Shots were also taken across the estuary and river channel in several areas. The points in the channel and estuary will be useful in monitoring changes in volume of the sediment stored in the estuary.

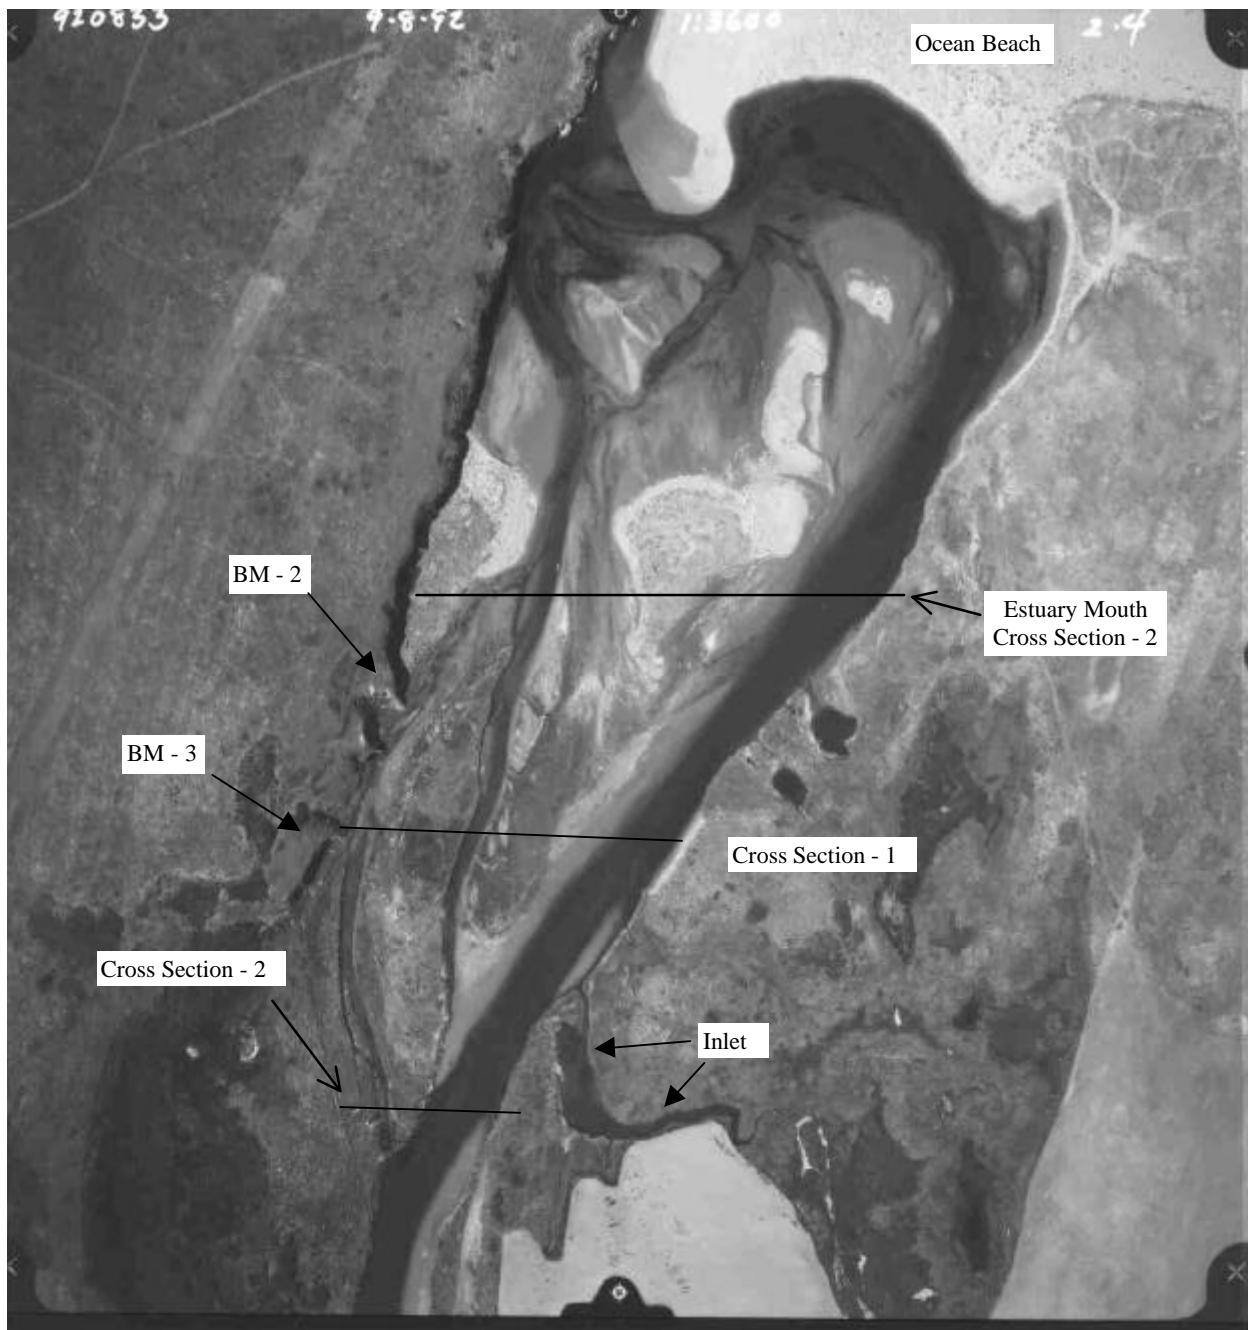
Figure 2. Location of Garcia River Estuary cross sections surveyed in 1998. September 1992 aerial photo.

The approximate locations of the six cross-sections were marked on aerial photos from September of 1991 and are shown in Figures 2 through 4. An oblique aerial photo from the fall of 1998 is shown in Figure 4. Figure 5 is a photo mosaic of the base photos used in Figures 1 through 3. Comparison of Figures 4 and 5 shows the overall changes in the estuary between 1992 and 1998.

Figure 11 shows the three surveys for cross section 1. Cross section 1 is approximately 622 feet downstream of cross section 2. The cross section starts on the left bank at the base of the bluff. BM-3 is on the bluff above the cross section endpoint, but the endpoint is not visible from BM-3. However, the endpoint for cross section 1 is visible from BM-2 on the bluff just to the north, see Figures 1 and 2.

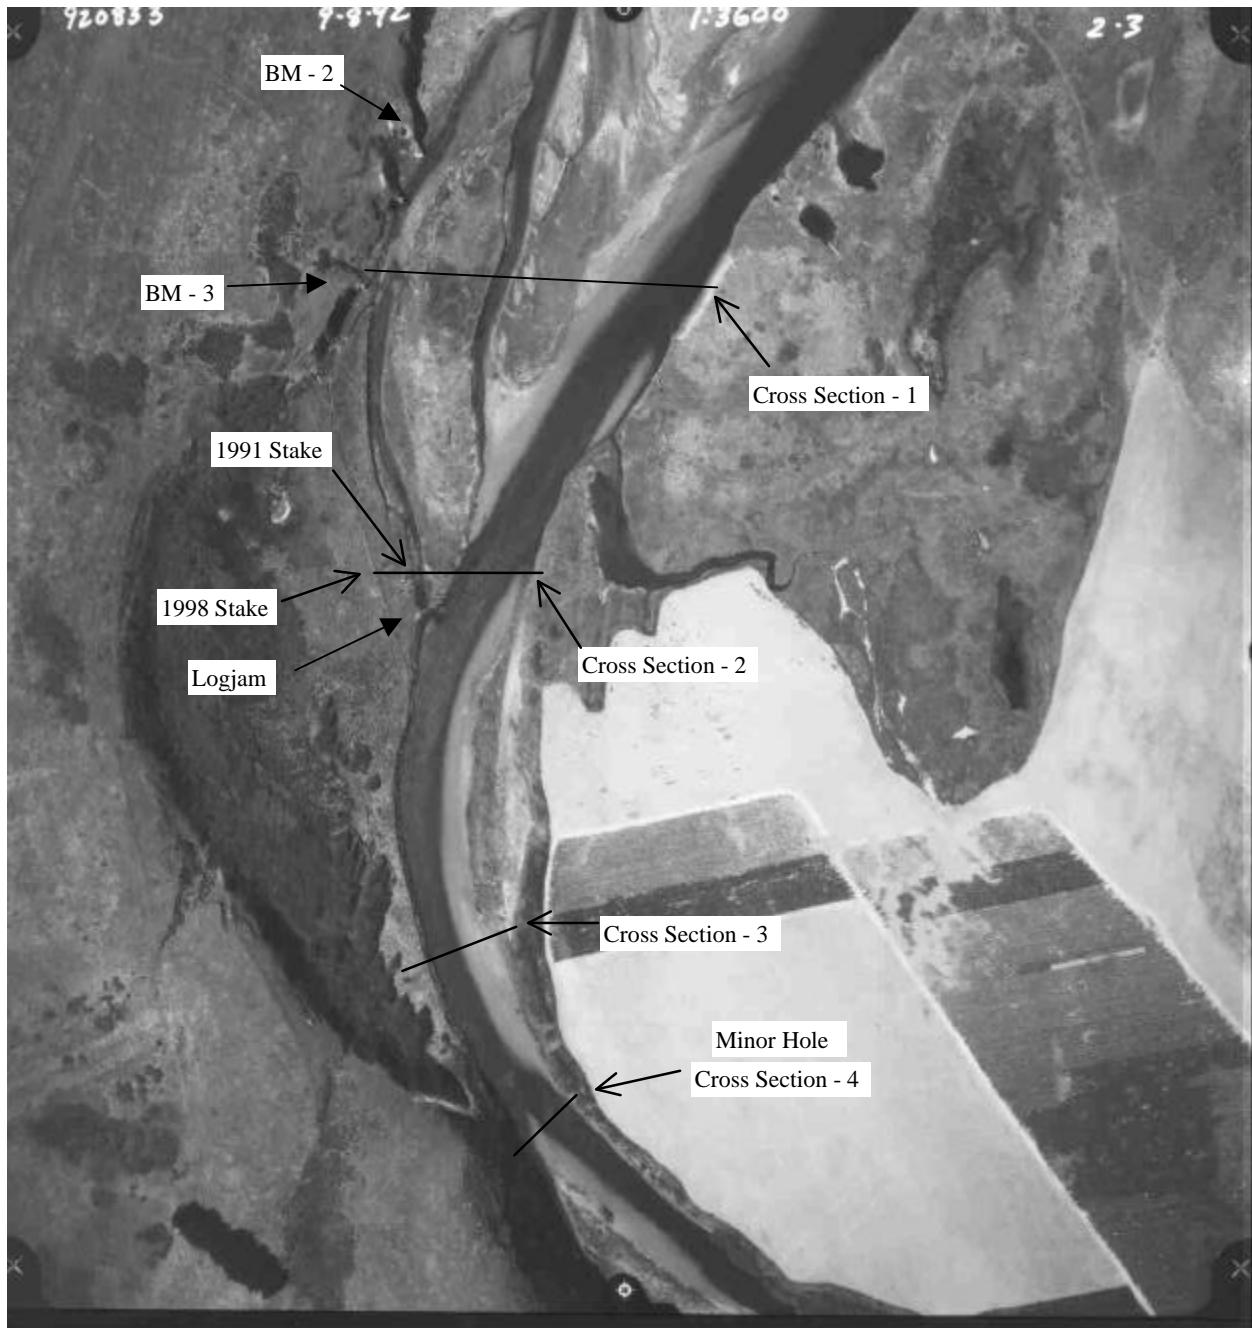
Figure 3. Location of Garcia River Estuary cross sections surveyed in 1998. September 1992 aerial photo.

The thalweg lies along the left edge of the channel. Figure 3 shows that the left side of the channel is the outside of a bend. The deepest point actually surveyed had an elevation of -2.4 feet and was about 24 feet away from the left edge of the channel.

Figure 10 shows the three surveys of cross section 2. Cross section 2 is located about 762 feet downstream of cross section 3, see Figures 1, 2 and 3. The cross section passes about 68 feet downstream

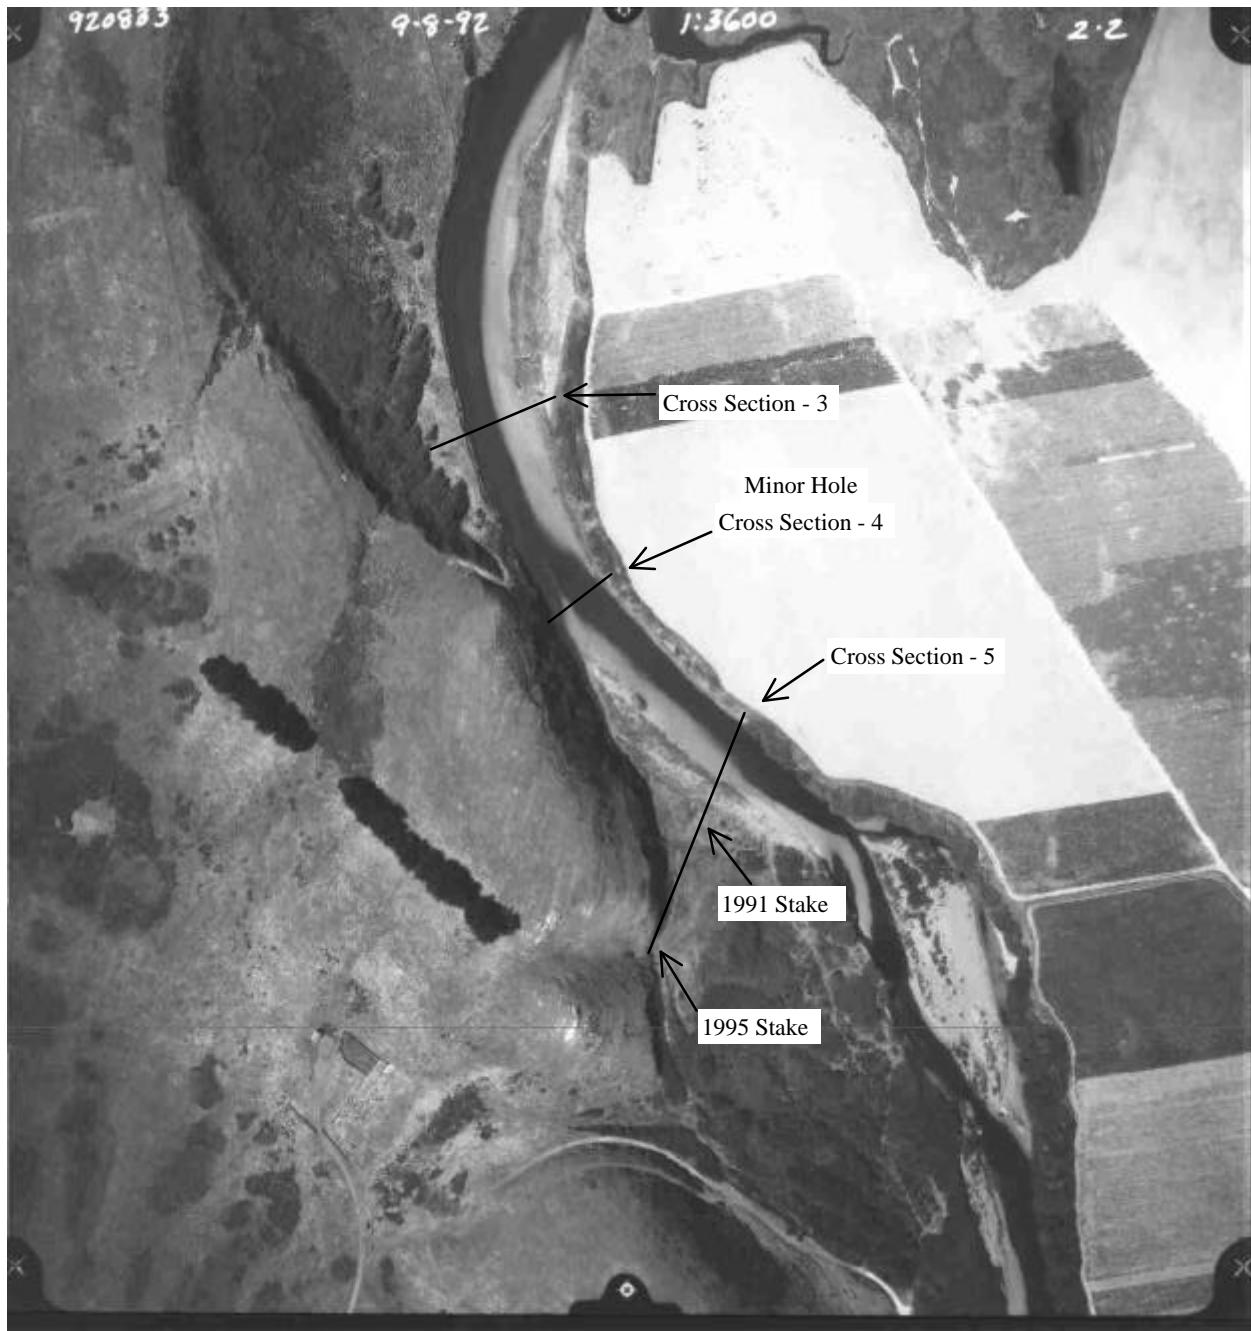
Figure 4. Location of Garcia River Estuary cross sections surveyed in 1998. September 1992 aerial photo.

Figure 4 shows that, in 1992, there was a bar stretching from upstream of cross section 5 down to cross section 4 along the left bank. By 1998, this bar was no longer visible and the river hugged the cliff on the left bank.

Field observations show that the bar along the left bank, between cross sections 4 and 5, in Figure 4, is no longer there. The distance between the cross sections is too great to adequately characterize the changes that have occurred. To help alleviate this problem in future surveys; we took a number of spot elevations, between cross sections 4 and 5, on the exposed gravel along the right bank and in the channel.

Figure 4 shows that approximately one vertical foot of material was removed in the tidal zone on the right bank. Deposition occurred on the upper right bank, above +4.0 feet in elevation.

A comparison of aerial photos (Figure 4) suggests that the areal extent of the central bar decreased between 1992 and 1998. However, it is not possible to ascertain if there was deposition in the channels to offset the erosion of the central bar observed on the aerial photos. Additional cross sections are needed on both the upstream and downstream side of the Mouth-2 cross section to track changes below the water surface. Additional cross sections toward the ocean would be very helpful since the distance between cross section mouth 2 and the beach is approximately 1,100 feet. The additional ground shots we took between cross section mouth 2 and the beach at the waters edge and on top of the adjacent bank plus the shots we took in the channel between will provide invaluable information about changes in the lower part of the estuary if the estuary is ever surveyed again.

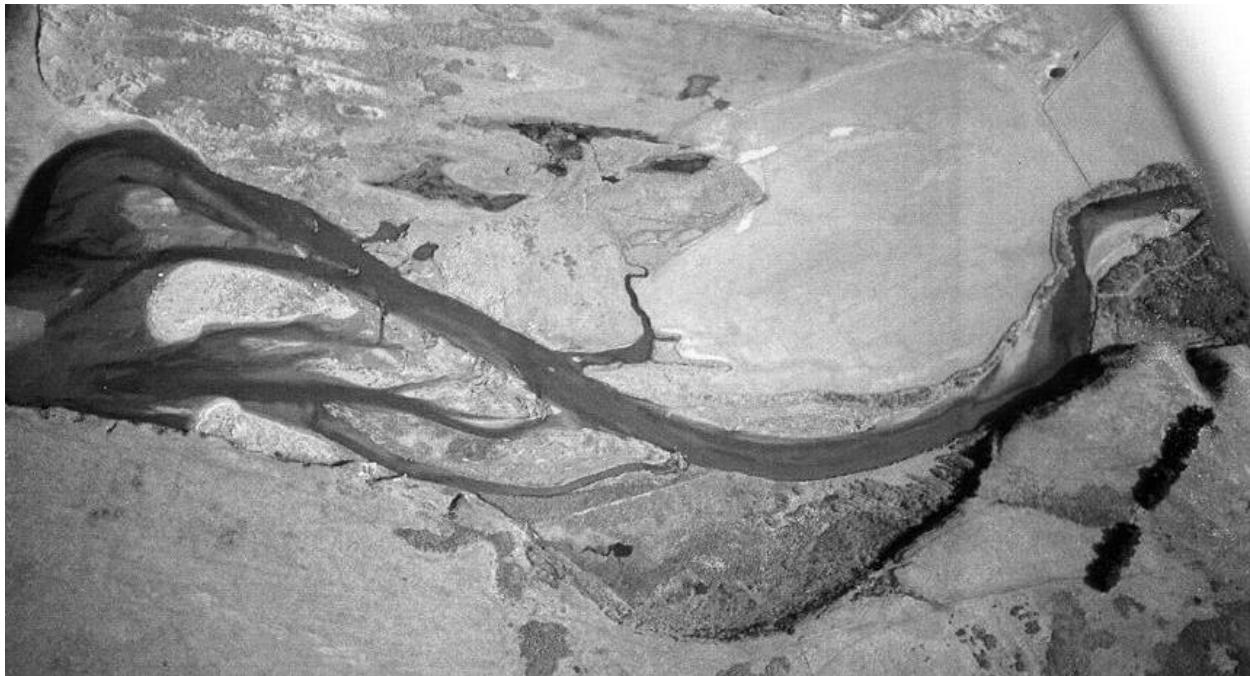
Figure 5. Fall 1998 oblique aerial photo of Garcia River estuary. Ocean is to the left.

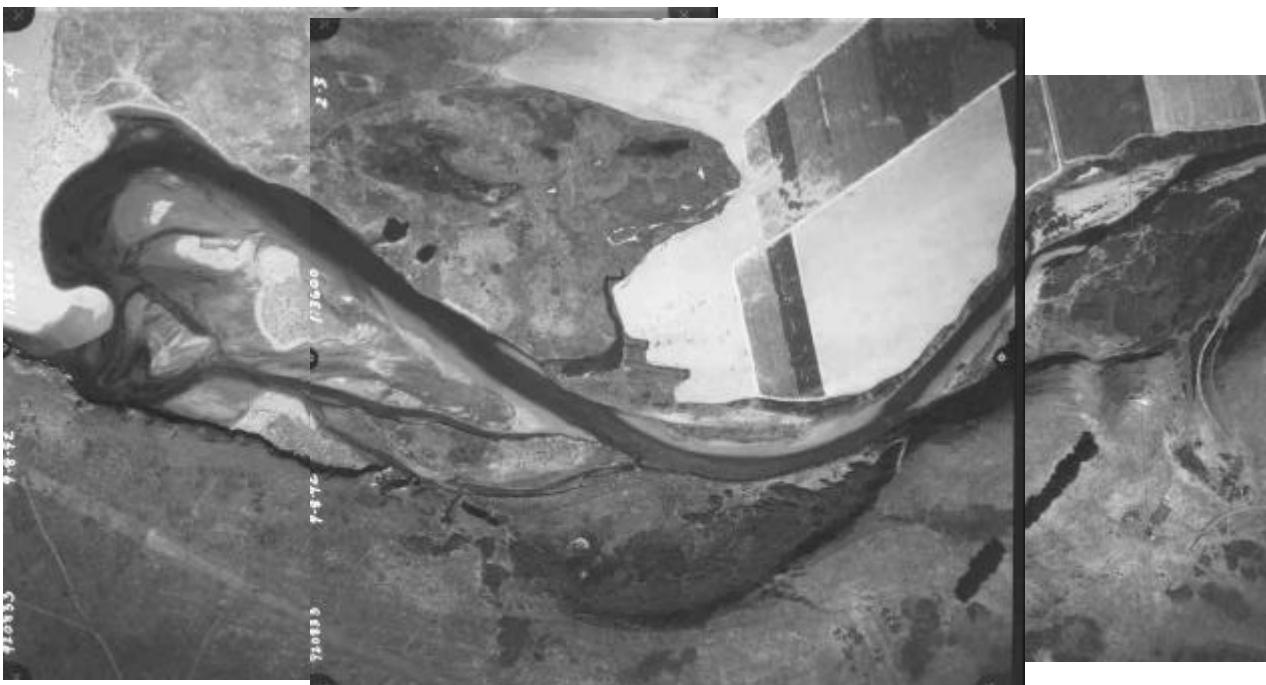
Figure 6. Photo mosaic of September 1992 aerial photos. Ocean is to the left.

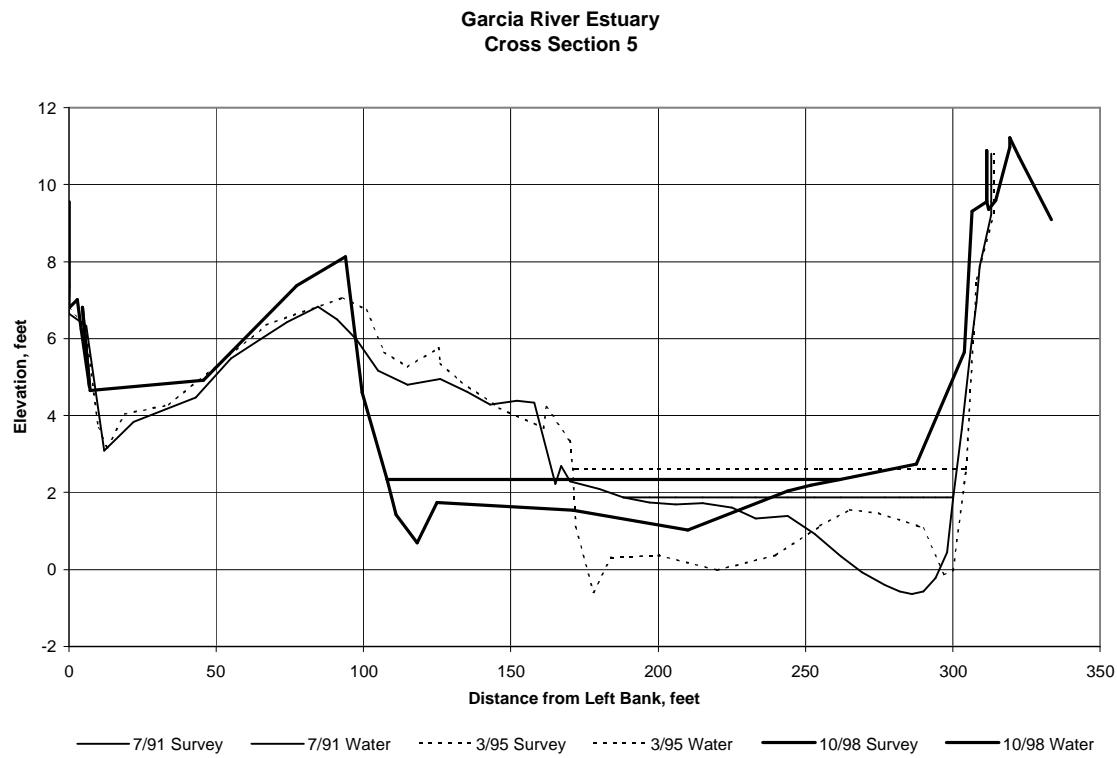
**Figure 7.** Garcia Estuary Cross Section 5. Approximately 480 feet upstream of Minor Hole.

Cross section 5 is the upstream most cross section. In 1998, there was a riffle just downstream of the cross section. The left bank benchmark from 1991 was not found in 1998. The coordinates of the left bank benchmark were established in 1995. A wooden stake was driven in the ground at the approximate location of the 1991-left-bank benchmark.

By 1995, a shoal had replaced the thalweg by the right bank. The thalweg had shifted to the left bank but stayed at the same elevation of -0.6 feet. There was some minor deposition on the left bank.

By 1998, the width of the low-flow channel had widened over 50 feet. Material had been deposited across the entire channel bottom causing the thalweg to rise 1.1 feet to an elevation of +0.7 feet. The channel widened at the expense of the left bank bar.

Figure 7 shows the three surveys of cross section 5. In 1991, the thalweg was against the right bank. The elevation of the thalweg was -0.6 feet, indicating that water surface elevation is influenced by tidal action.

The cross section area is calculated by drawing a horizontal line across the diagram of the cross section at a specific reference elevation and determining the area between the ground surface and the reference line. The elevation of the reference line for cross section 5 was 9.55 feet.

The area of the cross section (Table 1) increased slightly (101.1% of the 1991 area) between 1991 and 1995 indicating net erosion of material from the cross section. By 1998 the area decreased to just slightly less than its 1991 value (99.4%). However, since the decrease in area was less than 1% we judge that the 1998 cross section area is the same as the 1991 area.

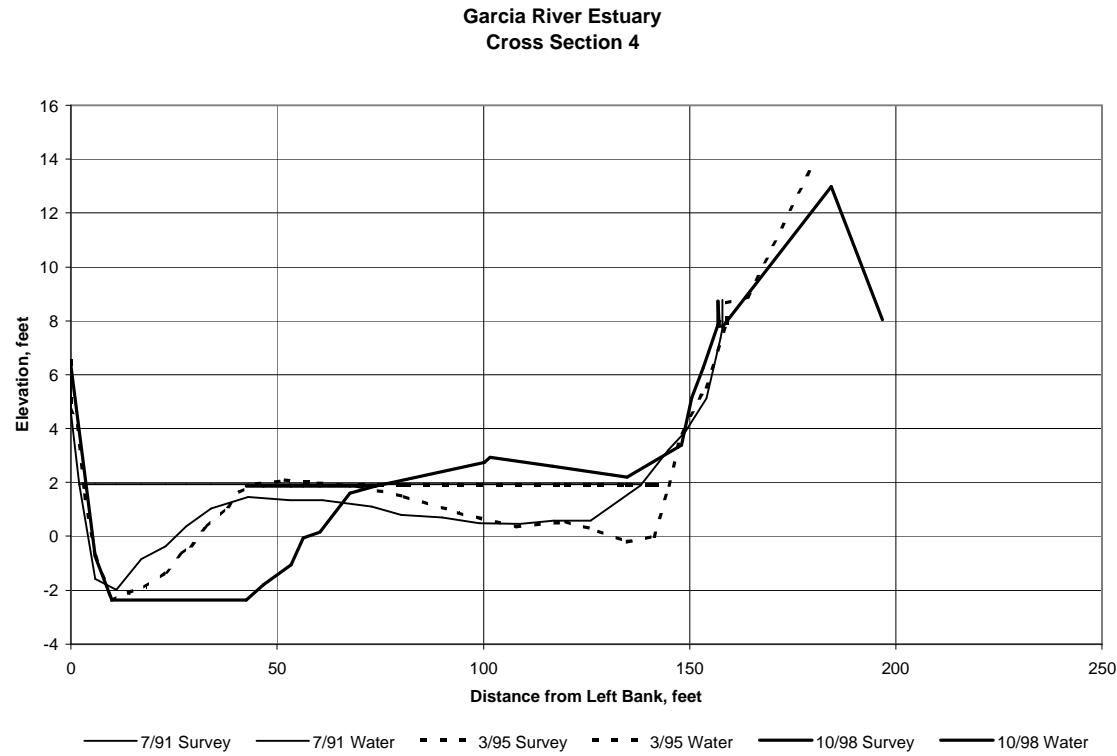
**Figure 8.** Garcia Estuary Cross Section 4. Located at Minor Hole. The thalweg was not measured. The thalweg shown in the graph of the cross section is the deepest point measured, which is the same as the 1995 thalweg.

Cross section 4 is located at Minor Hole, approximately 482 feet downstream of cross section 5. In 1991, the end of the bar along the left bank reached just downstream of the cross section. The higher tides inundate the bar. The surveys of cross section 4 for 1991 and 1995 are very similar. The reference elevation for calculating the area of cross section 4 was 8.0 feet above sea level.

Figure 8 shows the three surveys of cross section 4. The survey of 1998 shows that the deeper portion of the channel, near the left bank, has widened about 20 feet. The tidal conditions at the time of the survey made it impossible to wade completely across the channel. The deepest point measured in 1998 was -2.4 feet and was 42.5 feet from the location of the left bank stake. The depth of the true thalweg was not determined. Note that the elevation of the 1995 thalweg was also -2.4 feet, the same as the deepest point measured in 1998.

The thalweg for cross section 4 was estimated using two different methods. The first method was to assume that the deepest point measured is a good estimate of the thalweg. By this method the thalweg for cross section 4 is -2.4 feet.

The second method was to use the cross-channel slope, at the deepest point measured, to estimate the thalweg. This method yields -6.9 feet as an estimate of the thalweg elevation.

The widening of the deeper portion of the channel was accompanied by deposition in the right hand half of the channel. The cross section area increased slightly between 1991 and 1995, the 1995 area was 101.2% of the 1991 area. Using the deepest point measured as the thalweg, the 1998 cross section area was 99.4% of the 1991 area, indicating virtually no change in cross section area. Using the cross-channel slope to estimate the thalweg leads to a cross section area of 106.9% of the 1991 area, indicating an increase in cross section area. Taken together, the two area estimates clearly show that net deposition did not occur at the cross section. Furthermore, the two area estimates indicate the cross section area probably increased, indicating the cross section experienced erosion.

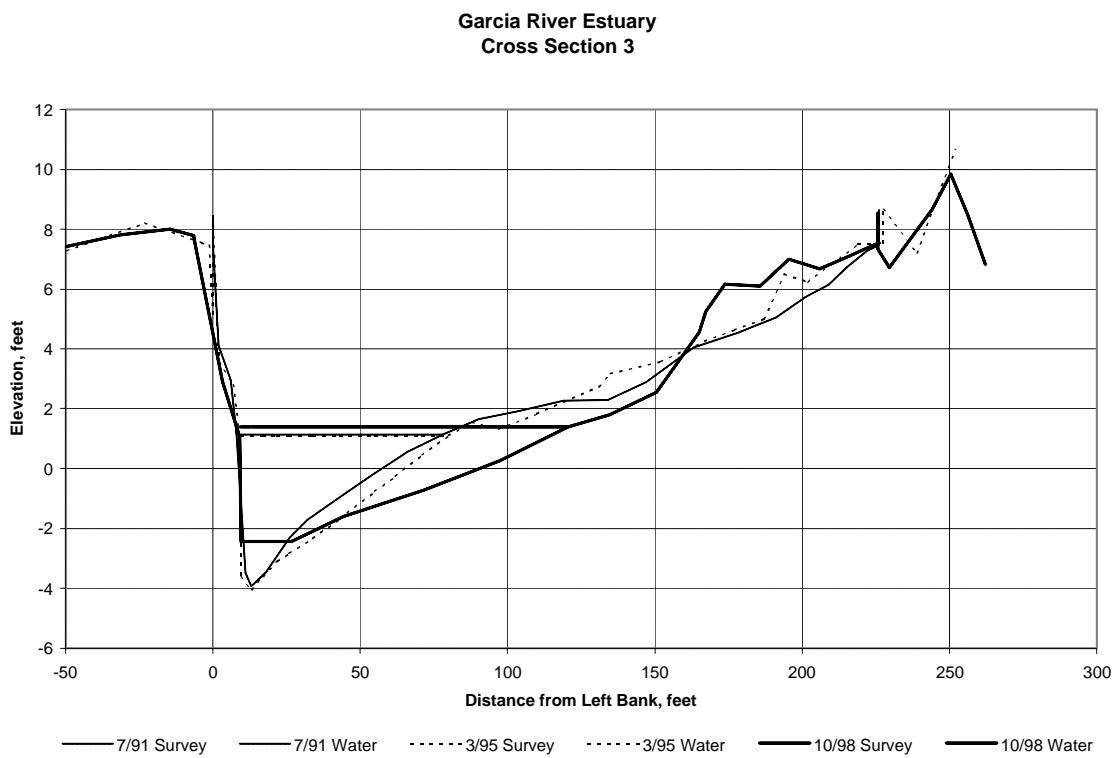
Figure 9. Garcia Estuary Cross Section 3. Located 435 feet downstream of Minor Hole. The thalweg was not measured. The thalweg shown in the graph of the cross section is the deepest point measured.

Cross section 3 is located about 435 feet downstream of cross section 4 (Minor Hole). The level of the tide prevented locating the thalweg at cross section 3. One method of estimating the thalweg is simply using the deepest point measured. In 1998, the deepest point measured was -2.4 feet below sea level. Another estimate of the thalweg is to used the cross-channel slope, which yields -3.2 feet.

Figure 9 shows the graph of the three surveys. Between 1991 and 1995 the cross section area remained the same. The two estimates for the 1998 thalweg yielded areas of 1290 and 1297 square feet, or 106.8% and 107.4%, respectively. There is less than 1% difference between the two area estimates so we can conclude that there is no real difference between the two estimates. Thus, between 1995 and 1998 the cross section area increased about 7%, indicating erosion of the cross section. The reference elevation for calculating the area of cross section 3 was 7.54 feet above sea level.

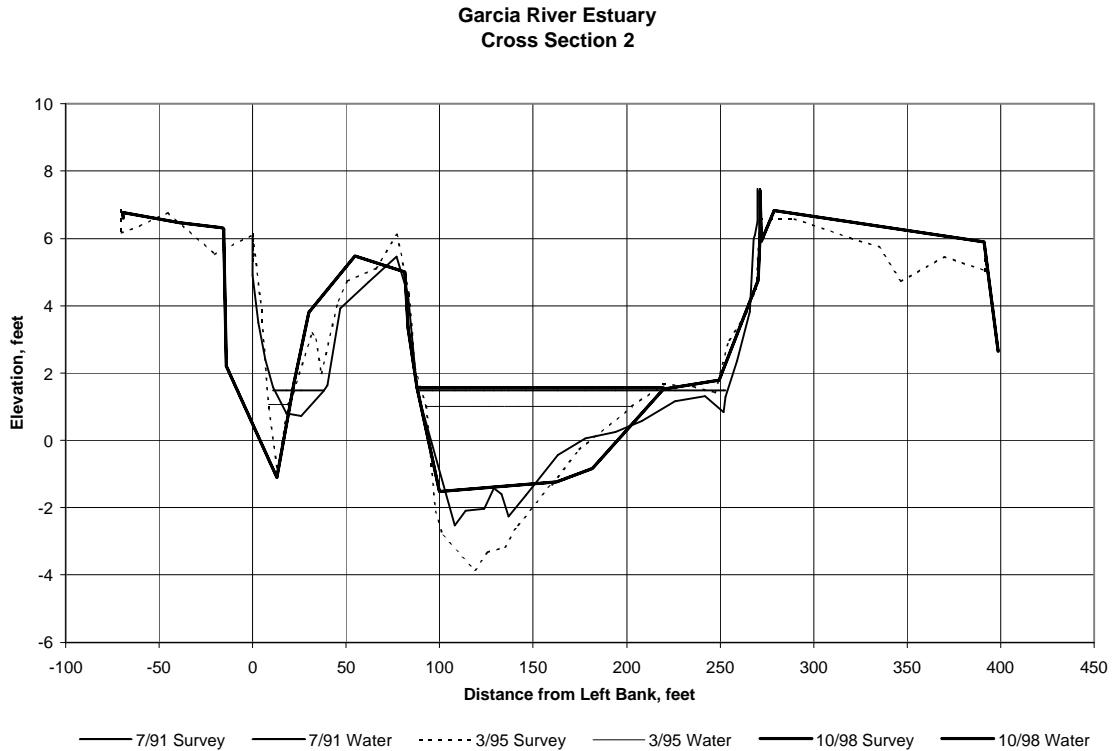
Figure 10. Garcia Estuary Cross Section 2. Located near head of side, just downstream of logjam. The thalweg was not measured. The thalweg shown in the graph of the cross section is the deepest point measured.

of the side channel on the left bank. On the right bank, the cross section is about 286 feet upstream of the mouth of the small inlet. There is a logjam across the mouth of the left bank side channel.

The logjam has caused significant local scour in the main channel. The scour and the cover of the logjam create some of the best fish habitat available in the estuary. During the survey, we observed an otter resting on the logjam.

Tidal conditions again prevented wading across the channel along the cross section. Using the deepest point measured as the estimate of the thalweg yields an elevation of -1.5 feet. Using the cross-channel slope to estimate the thalweg yields -2.3 feet below sea level.

Between 1991 and 1995 the area of cross section 2 changed by only 0.2%, so, we judge that there was no real change in cross section area. The deepest point measured estimate of the thalweg yields a 1998 cross section area that is 99.7% of the 1991 area, indicating that there was no real change in area. The estimate of the thalweg derived from the cross-channel slope yields a 1998 cross section area that is 103.9% of the 1991 area, indicating that the cross section experienced erosion. The reference elevation for calculating the area of cross section 2 was 6.11 feet above sea level.

The scour hole on the left bank side channel appears to offset the deposition in the main channel on the 1998 survey. Of course, the deposition in the main channel may be an artifact of our attempt to estimate the thalweg elevation.

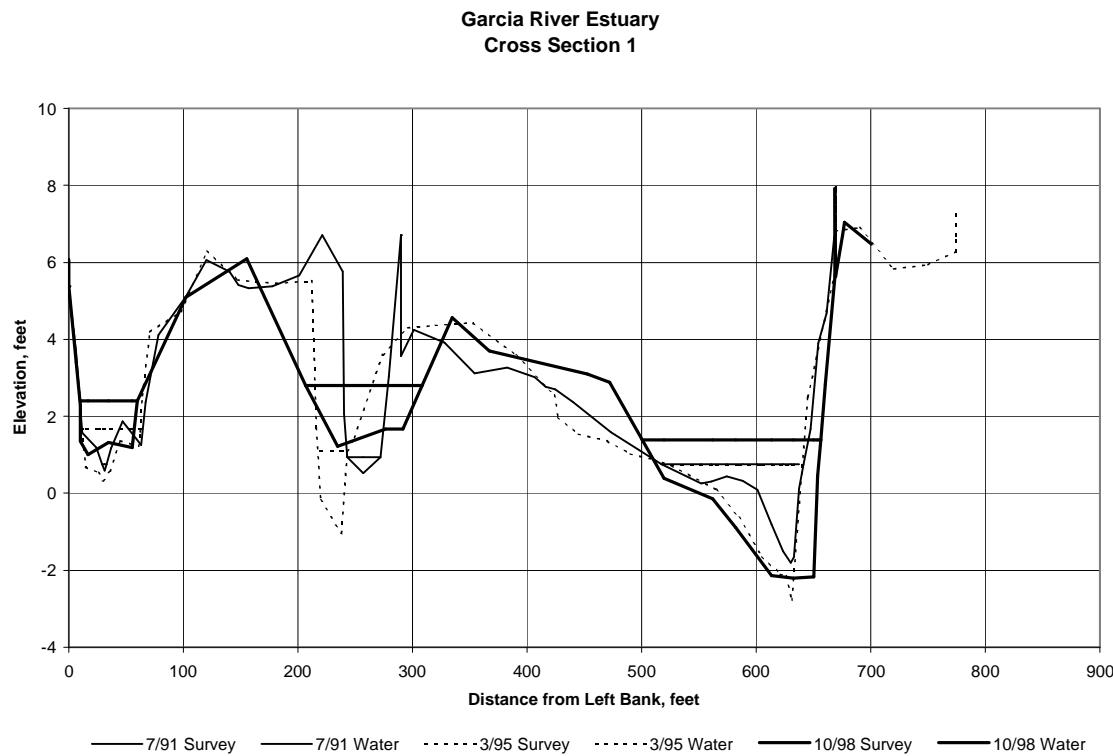
**Figure 11.** Garcia Estuary Cross Section 1. Located at base of the bluff, below BM-3.

There are three distinct channels visible at cross section 1. The small channel on the left bank starts just upstream of cross section 2. This is the channel with the logjam. The central channel starts a short distance downstream of cross section 2. The channel on the right is the main river.

The thalweg of the small channel on the left bank has risen about 0.5 feet since 1991. The channel bottom is now more uniform than it was in 1991.

The bar between the left and central channels has been significantly eroded along its right edge. The central channel has changed from a narrow deep channel in 1991 and 1995 to a broad channel in 1998. The thalweg of the central channel has risen about 0.75 feet since 1991. Its width increased from about 50 feet in 1991 to about 100 feet in 1998. The increase in channel width came at the expense of the bars on each side of the central channel.

The thalweg of the main river channel was at an elevation of -2.2 feet, in 1998. So, the thalweg has risen since 1995 but declined in elevation since 1991. The left bank of the river channel has eroded slightly, but the cross section endpoint was still in place.

The area of the cross section has increased with each successive survey. Between 1991 and 1995 the area increased by 10%. Between 1995 and 1998, the area increased an additional 2%, relative to 1991. Thus,

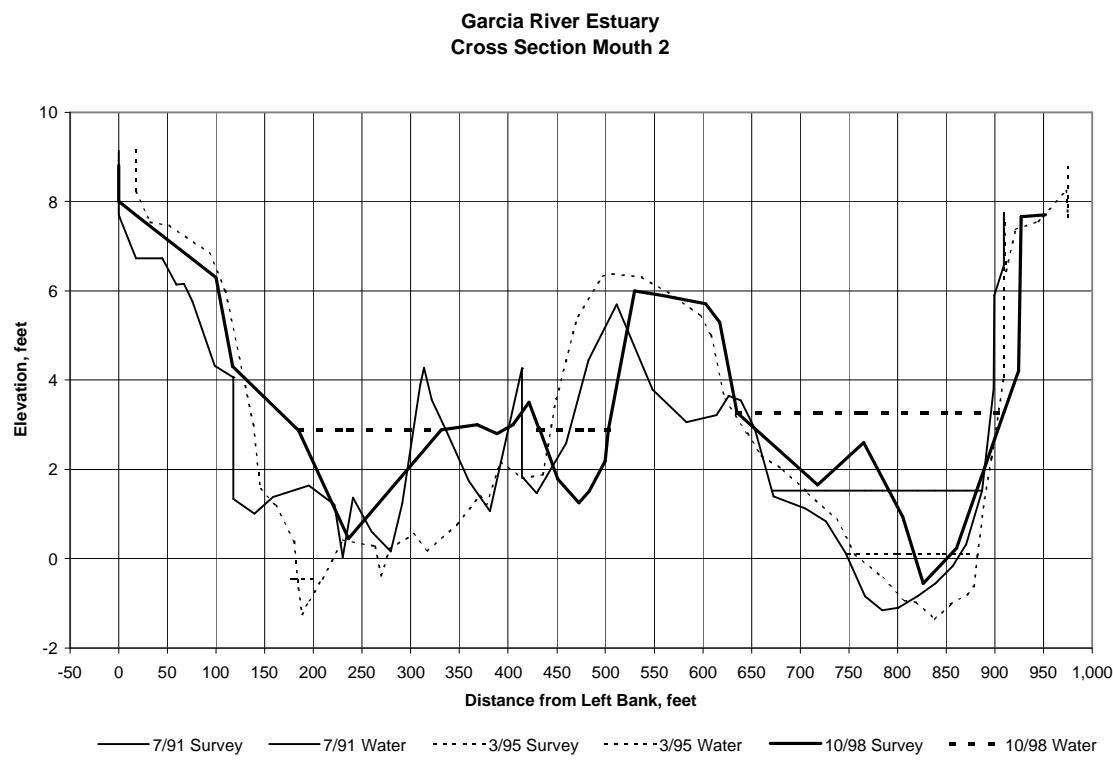
**Figure 12.** Garcia Estuary Cross Section Mouth 2. Located at base of bluff and north of BM-2.

Figure 12 shows the three surveys for cross section Mouth-2. In 1995, McBain could not locate the left bank endpoint. As a result, the alignment of the 1995 cross section was not accurate so, the total length of the cross section is not the same as the 1991 length. In 1998, neither endpoint could be located. However, the coordinates of the right bank endpoint were established in 1995 so it was possible to locate the position of the stake. It was found that the right bank had eroded several feet and that the right bank endpoint had been washed out. No coordinates were established for the 1991 or 1995 left bank endpoints. Therefore, we used diagrams from the 1991 field notes to select a line to shoot. Processing the data, after the survey was performed, gave us an opportunity to estimate the coordinates of the stations and turning points used to shoot the cross section in 1991. It turns out that the line we shot in the field reached the left bank downstream of the 1991 cross section. Therefore, we had to estimate much of cross section Mouth-2 from nearby ground shots. However, this did not effect our main channel shots since they are close to the known right bank endpoint.

The thalweg of the main channel is near the right bank. The thalweg elevation declined from 1991 to 1995 and then rose from 1995 to 1998. The thalweg was 0.6 feet higher in 1998 than it was in 1991. A low bar had formed near the left edge of the main channel in 1998.

Between 1991 and 1995 the central bar, between 450 feet and 650 feet on Figure 12, grew significantly. However, between 1995 and 1998, the left 50 feet of the central bar was eroded.

In 1991 there were two bars and three channels between the left bank and the central bar. By 1998, deposition filled the middle channel creating a single bar from the two bars adjacent to the filled in middle channel. In 1995, the thalweg of the far-left channel was -1.3 feet. By 1998, the thalweg had risen about 1.8 feet to an elevation of +0.5 feet.

The total cross section area has declined each year at cross section Mouth-2, indicating that deposition was the dominant process at the cross section. The deposition appears to have been concentrated in the side channels and I the main channel. The emergent central bar appears to have been eroded. The reference elevation for calculating the area of cross section mouth-2 was 7.66 feet above sea level.

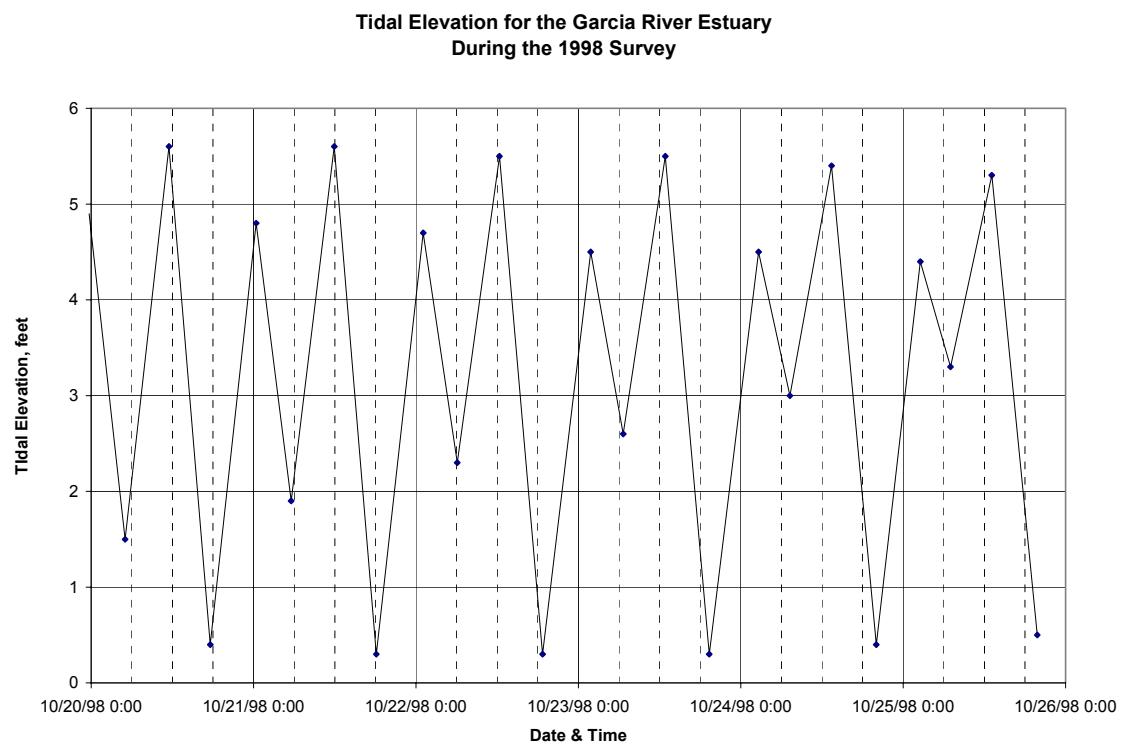
Figure 13. Tides for the Garcia Estuary during the October 1998 survey.

Tides effect the water surface elevation at all the cross sections surveyed in 1998. Therefore, the water surface reveals no information about the downstream control. The tides ranged from 5.6 feet to 0.3 feet during the 1998 survey. Figure 12 shows the daily tidal fluctuations during the 1998 survey. The high-high tide occurred between noon and 2 p.m. each day. The low-low tide occurred between 6:30 p.m. and 8:30 p.m. each day. The unfortunate timing of the tides made it difficult to survey the thalweg of the cross sections.
