**SURFACE WATER AMBIENT MONITORING PROGRAM  
(SWAMP)  
FINAL WORKPLAN 2002-2003**

**SAN FRANCISCO BAY REGIONAL WATER QUALITY CONTROL BOARD  
JUNE 2002**

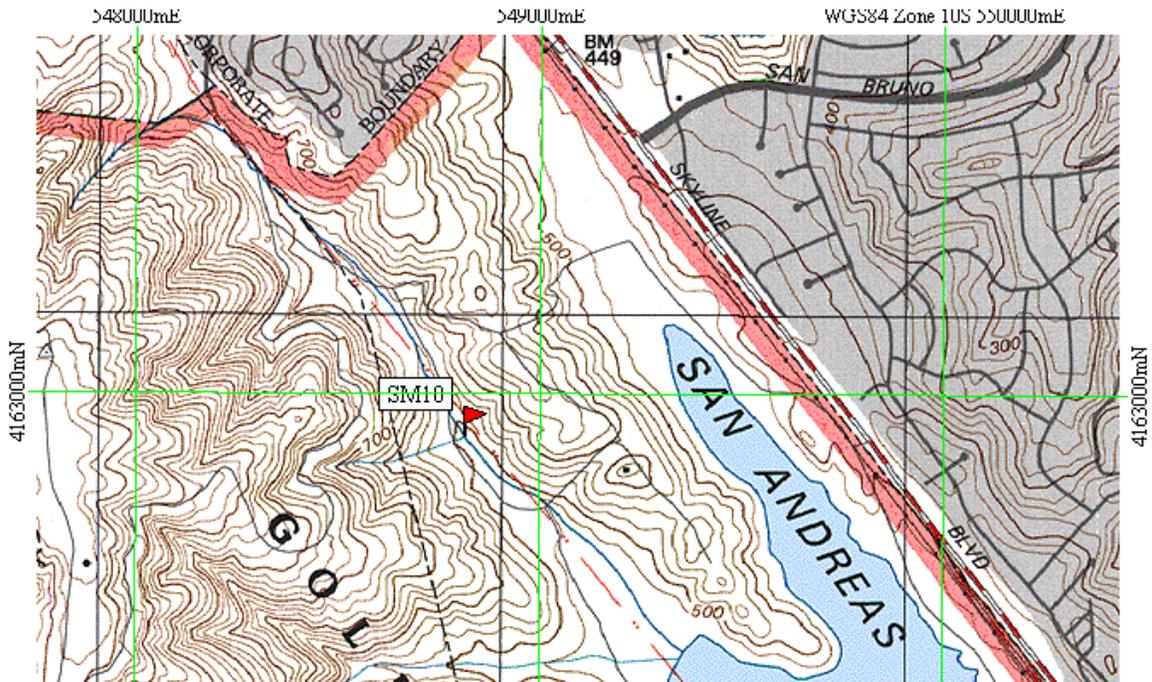
Map B-Site near Sweeney Ridge in upper San Mateo Creek watershed
