STREAM SURVEY

Date September 17, 1969

NAME....ANDERSON CREEK.....COUNTY.....MENDOCINO.....
 STREAM SECTION...Entire...FROM....Headwaters...TO.... Confluence with Robinson Creek....LENGTH...8mi....
 TRIBUTARY TO.....SOUTH FORK NAVARRO RIVER.....TWP.....14N....R..14W...Sec...19.....
 OTHER NAMES.....NONE KNOWN.....RIVER SYSTEM.....
 SOURCES OF DATA.....Personal observation.....

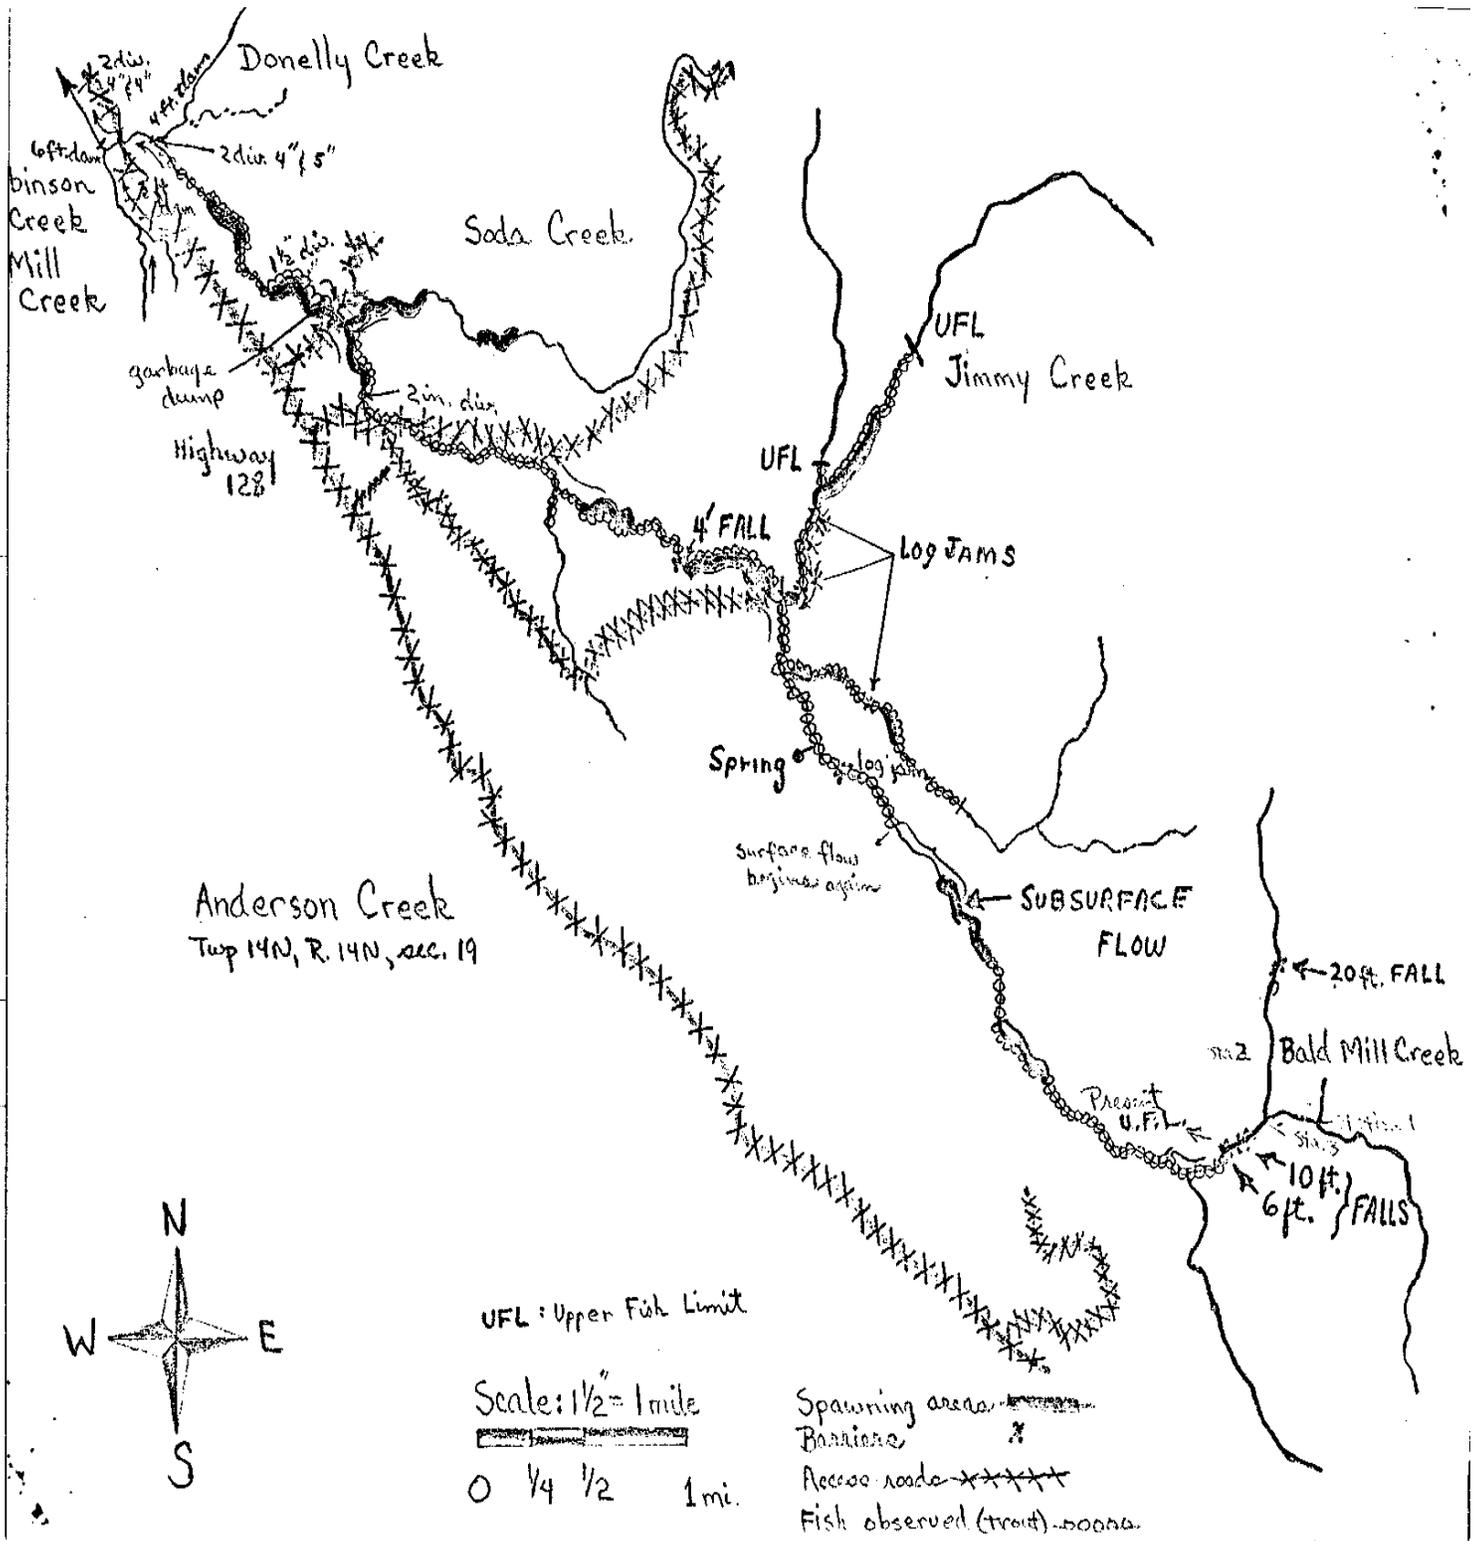
SKETCH MAP

BARRIERS: All barriers are plotted on the attached map. A total of 5 natural barriers and 3 artificial barriers were present on the main stream. A separate report on the tributaries will be filed. Three earthen dams for summer diversion were present. Four barriers (boulder and gravel) of various heights were observed and 1 potential log barrier. The 4' barrier located $\frac{1}{2}$ mile downstream from confluence of Jimmy Creek may limit some upstream migration. The log jam plotted $\frac{3}{4}$ mile upstream from confluence of Jimmy Creek is a potential barrier. The 10 ft. and 6 ft. falls appearing downstream from confluence of Bald Mill Creek appear to be complete barriers to upstream fish passage. In a pool below the 20 ft. falls on Bald Mill Creek a number of 8 to 12 inch Rainbow Trout were observed. Downstream from this pool no fish were observed until we reached the 10 ft. and 6 ft. barriers. Fish were seen, the rest of the way downstream except where flow was subsurface.

DIVERSIONS: Six diversions were observed. All were of the pumping station type. All appeared to be for irrigational or domestic purposes. Sizes land location of diversions are plotted on the attached map. All appeared to be for summer use.

SKETCH MAP: Map included as a $1\frac{1}{2}$ x enlargement directly from U.S.G.S. 15 minute series of Boonville and Ornbaun quadrants.
