**STREAM INVENTORY REPORT**

**DOTY CREEK**

**GUALALA REDWOODS**

**ENTRIX, Inc.**

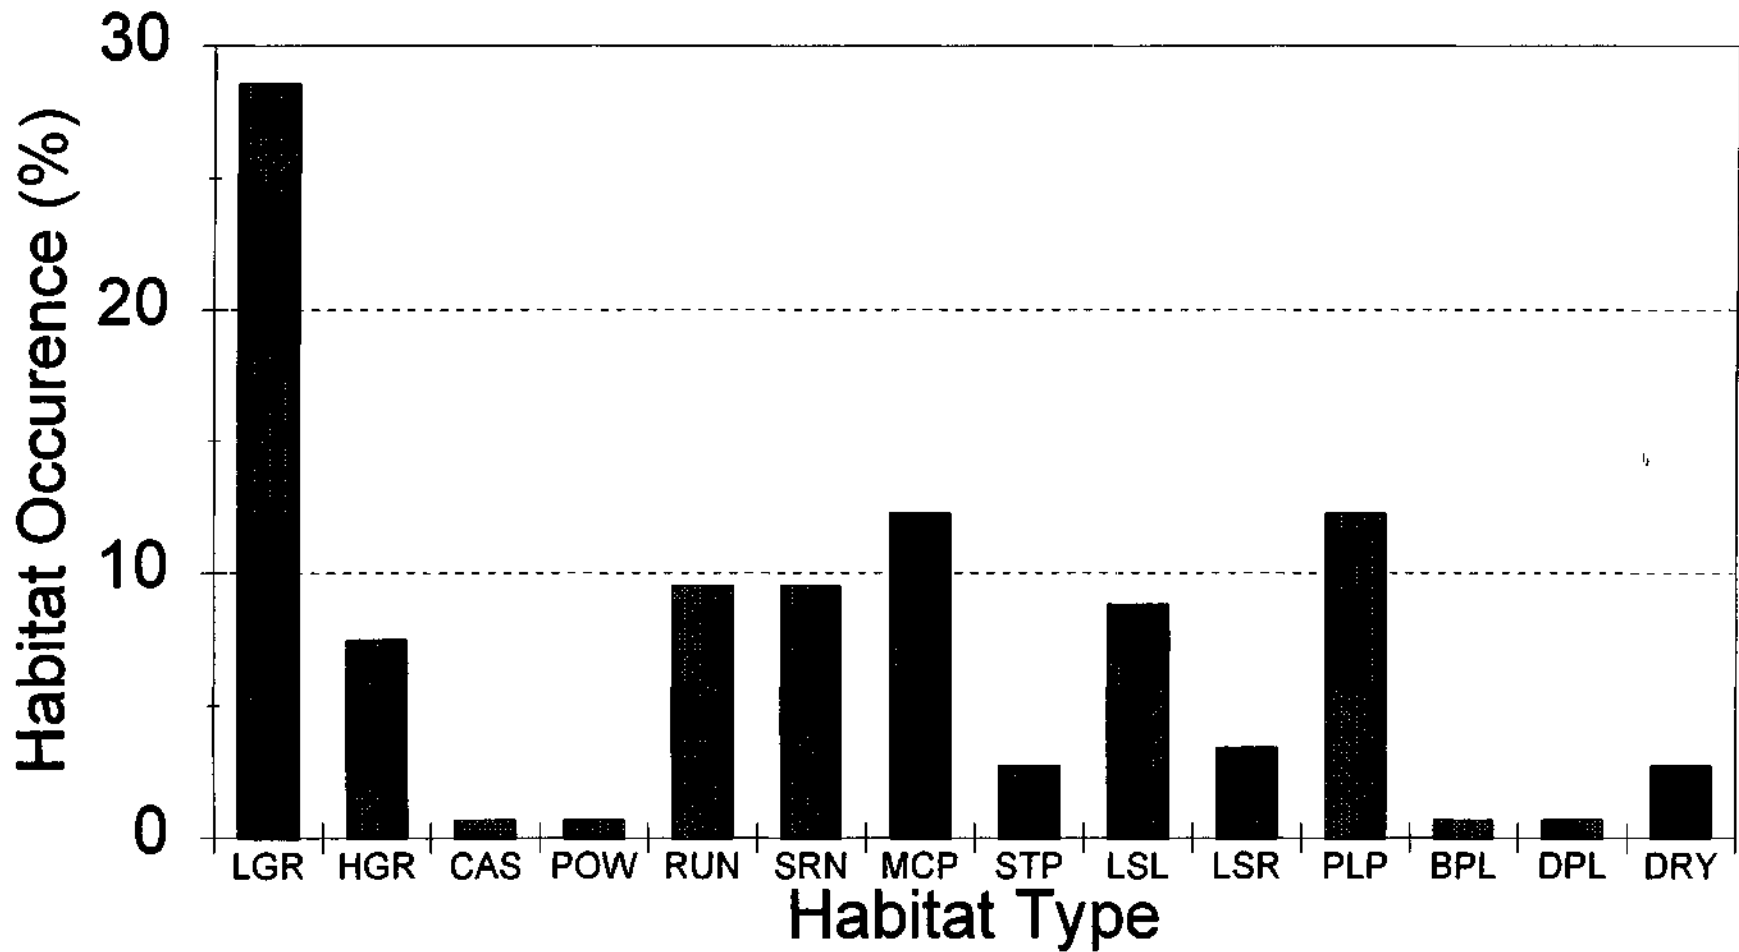
**Figure 3. Doty Creek Level IV Habitat Types  
by Percent Occurrence**

Fourteen Level IV habitat types were identified. The data are summarized in Table 2. The most frequent habitat types by percent occurrence were low gradient riffles, 29%; mid-channel pools, 12%; and plunge pools, 12% (Figure 3). By percent total length, low-gradient riffles made up 26%, step runs 14%, and high gradient riffles, runs, mid-channels pools, and step pools all totaled 6%.

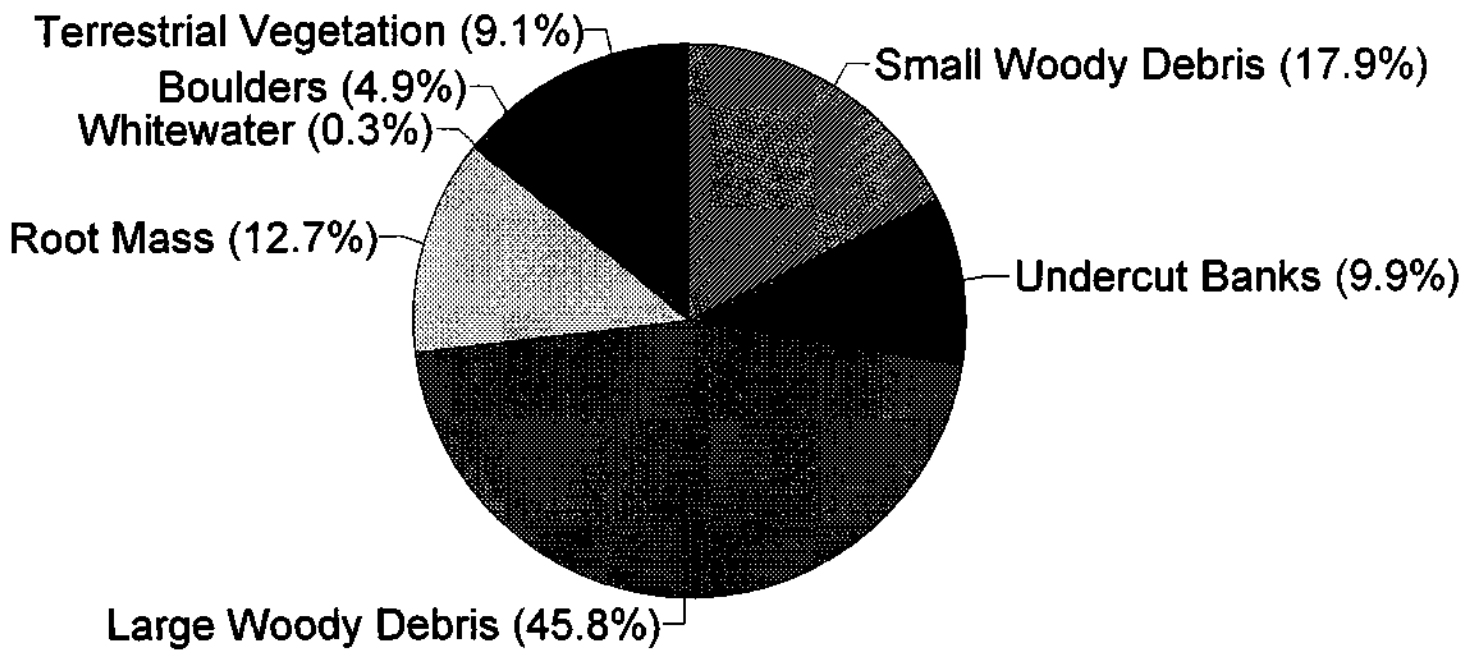
# Figure 7. Doty Creek Pool Cover by Cover Type

Table 5 summarizes mean percent cover by habitat type. Large woody debris is the dominant cover type in Doty Creek, with small woody debris and terrestrial vegetation comprising the subdominant cover types. Figure 7 describes the pool cover in Doty Creek in more detail.

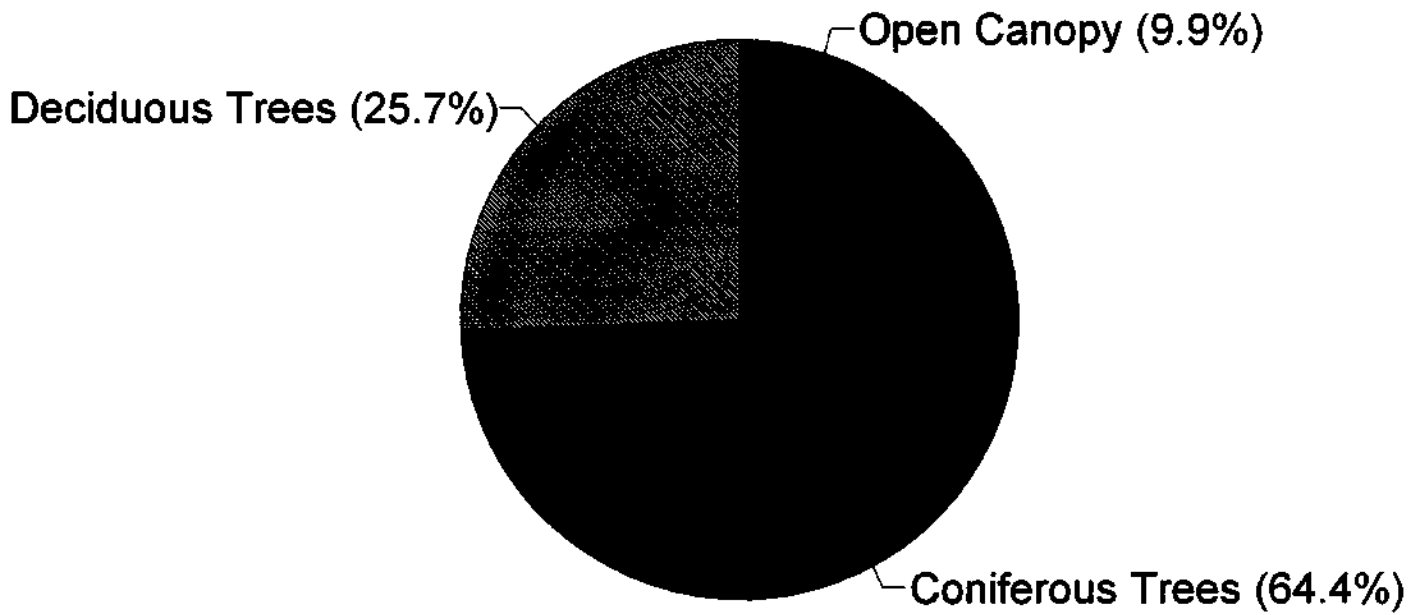
# Figure 9. Doty Creek Canopy Composition

The mean percent of open canopy for the entire portion of the stream surveyed was 10%. Of the 90% of the stream covered with canopy, 28.5% was composed of deciduous trees, and 71.5% was composed of coniferous trees. Figure 9 describes the canopy composition in Doty Creek.

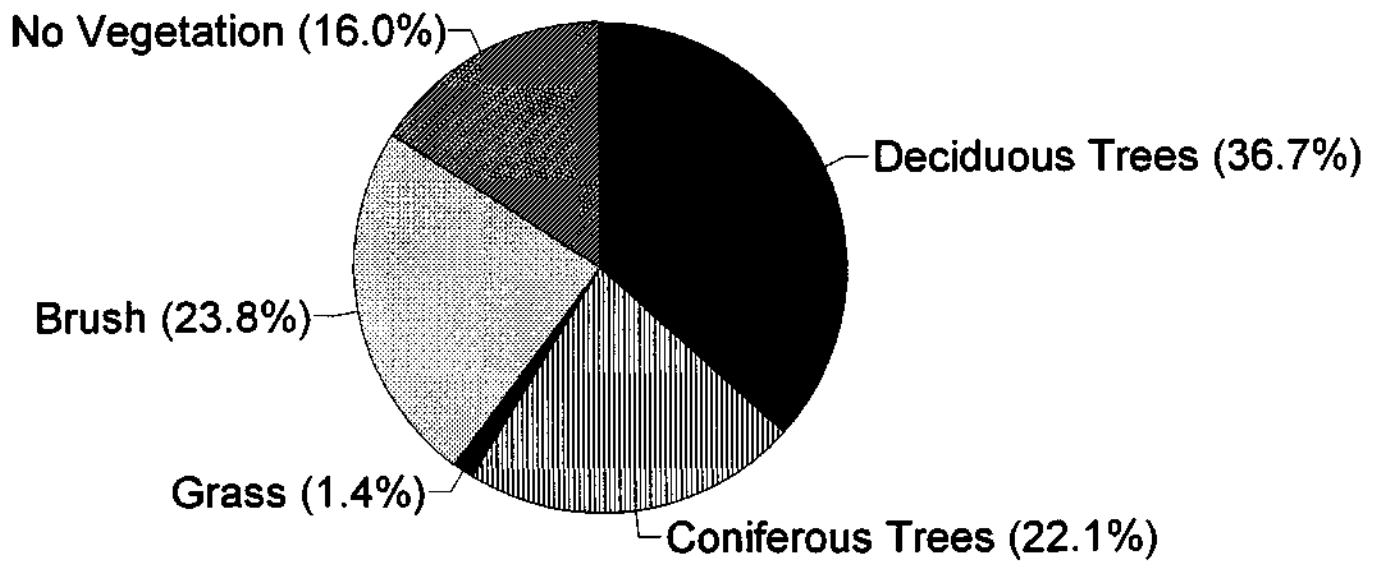
# Figure 10. Doty Creek Bank Composition by Dominant Vegetation Type

Table 2 summarizes the mean percentage of the right and left stream banks covered with vegetation by habitat type. For the stream reach surveyed, the mean percent right bank vegetated was 34.0%. The mean percent left bank vegetated was 37.2%. The dominant elements composing the structure of the stream banks consisted of 0.0% bedrock, 1.4% boulder, 49.3% cobble/gravel, and 49.3% silt/clay. The dominant vegetation present on both banks throughout the survey reach included 1.4% grass and 23.8% brush, while 36.7% of the banks were covered with deciduous trees and 22.1% with coniferous trees, including downed trees, logs, and root wads (Figure 10).
