STREAM SURVEY

Date: September 8, 1977

NAME: Holmes Canyon COUNTY: Sonoma

STREAM SECTION: entire FROM: Mouth TO: Headwaters LENGTH: 1.1 miles

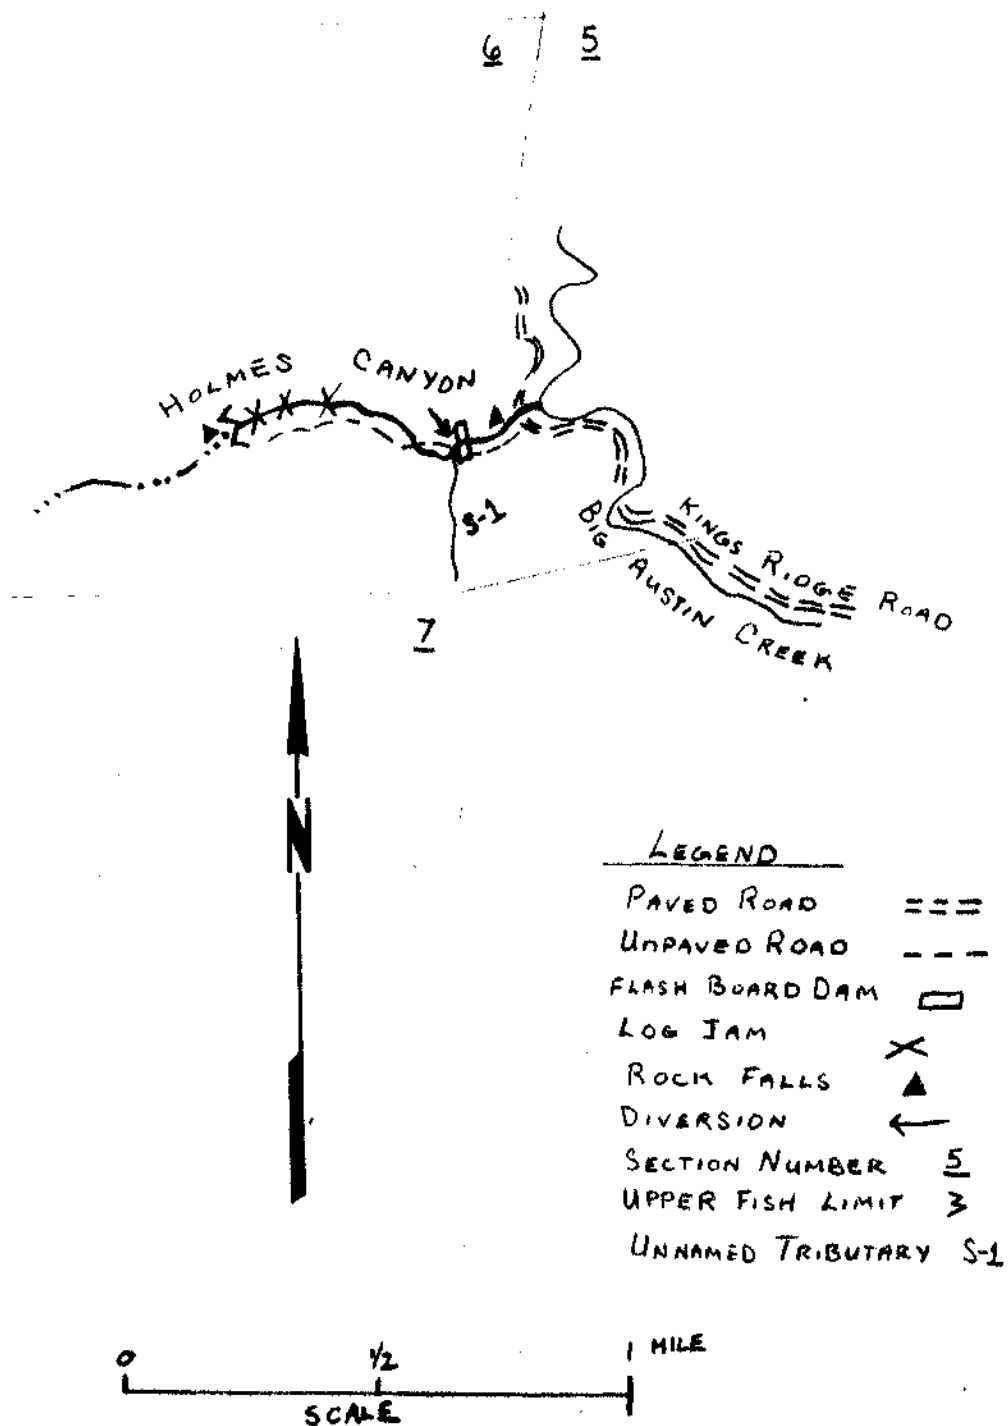
HOLMES CANYON

Barriers - Partial Barriers - A total of 3 log jams are located in the upper mid-section, ranging from 4 to 6 feet in height (see sketch map). From the mouth to 0.2 miles upstream steep gradient and bottom type dominated by boulders creates a series of falls that hinders fish movement at low flows. A cement and flashboard dam used for swimming and domestic water use is located 1000 feet below unnamed tributary S-1. A culvert located at the mouth under Kings Ridge Road creates a high velocity area.

IMPROVEMENTS - The removal of the 3 log jams in the upper mid-section would improve the streambed and increase the spawning habitat, along with improving fish distribution. A culvert approximately 100 feet long and 8 feet in diameter located at the mouth beneath Kings Ridge Road is creating a problem for migrating adult steelhead according to local residents. Investigation into the culvert creating a velocity barrier is advised.
